# Nukuhau Taupo Plan Change

Detailed Site Investigation

Date: September 2019  
Reference: 2-37400.01 / 007CL  
Status: Issue 1

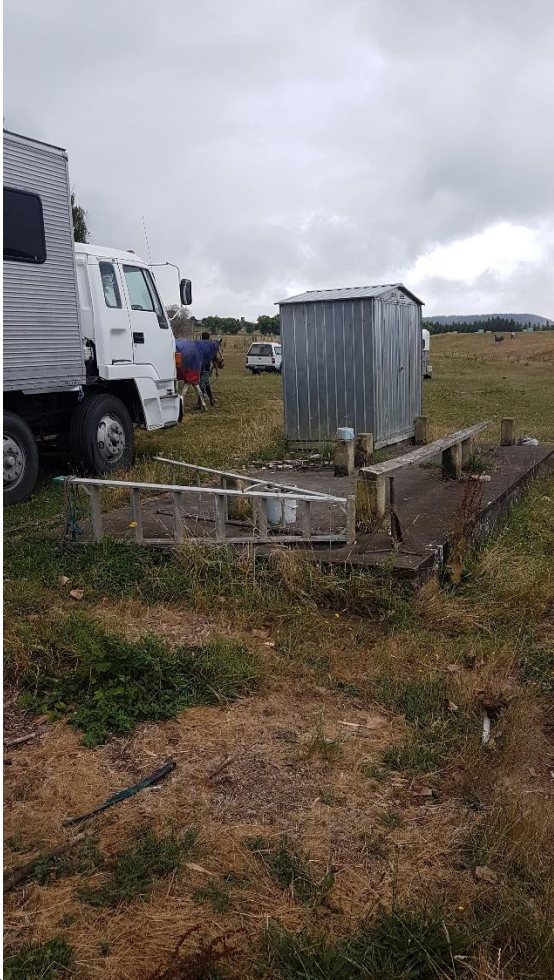
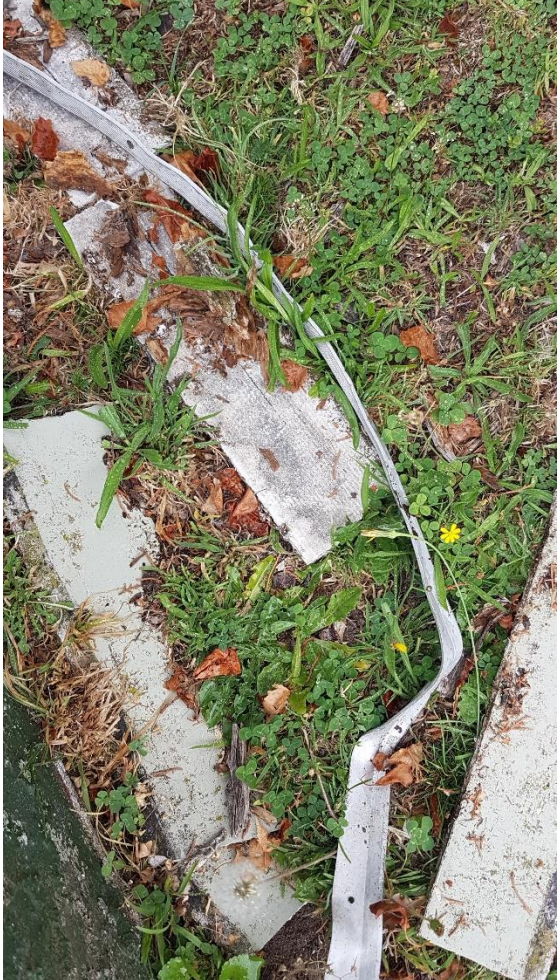
Site	Site Observations
<p>3</p>	<p>Foundation of what is presumed to be an old storage shed located as was the house. The old storage shed foundations have a new tin shed built on top of them. Some possible asbestos sheeting (asbestos containing material [ACM]) around the old house foundations. Remainder of the site was farmland with no obvious signs of contamination.</p> <div style="display: flex; justify-content: space-around;">

</div> <p>Foundations of old shed with new tin shed (Left), Possible ACM around foundations of old house (Right).</p>

- Material within 5m radius of the old shed and Foundation 2 does not exceed the human health SCSs. However, if it is to be removed from site, it should be disposed at a Class A Landfill because there is exceedance of the Class B landfill acceptance criteria and predicted background levels.

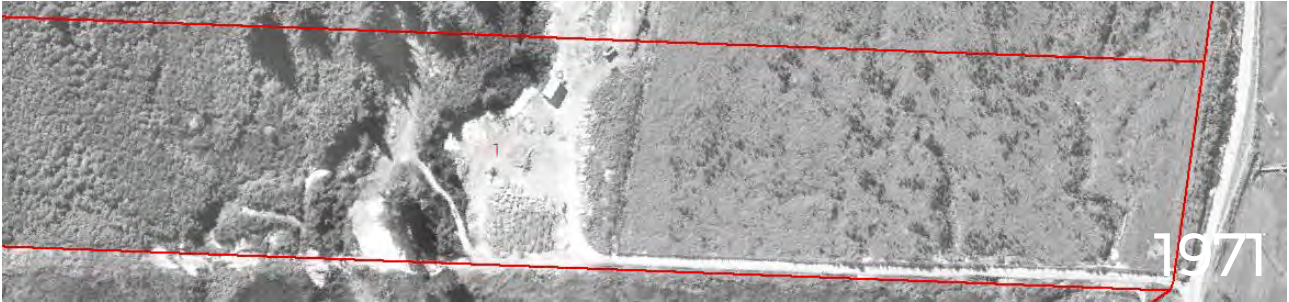
1971 - Fill Materials present plus building. Possible sawmill.

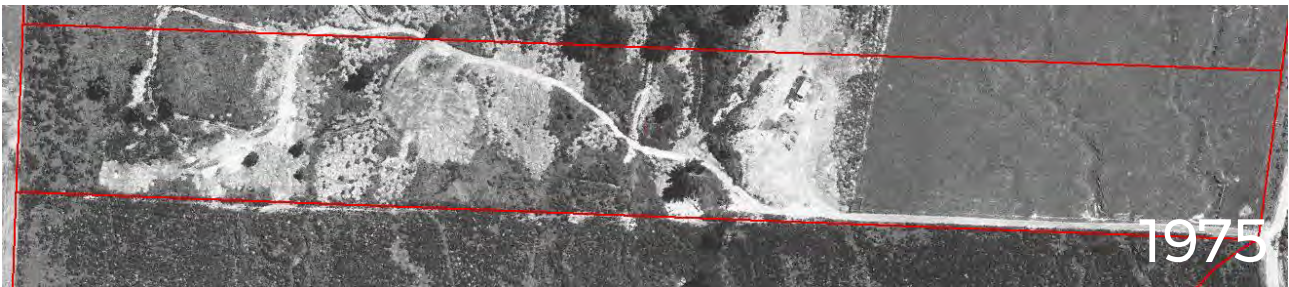
1975 - Road front appears to be pasture, rear of section appears to be forestry with some possible fill. Possible sawmill remains.

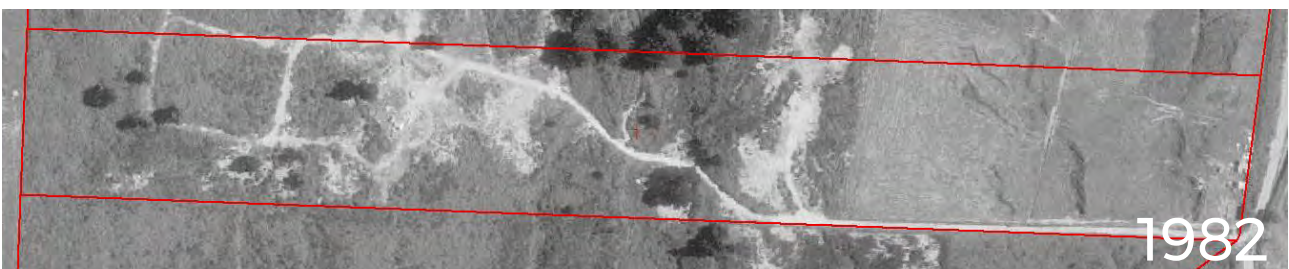
1982 and 1983 - Road front appears to be pasture with some small buildings / structures on boundary, forestry ceased with scrub/ bush regrowth from rear of section with some further possible fill. Possible sawmill remains.

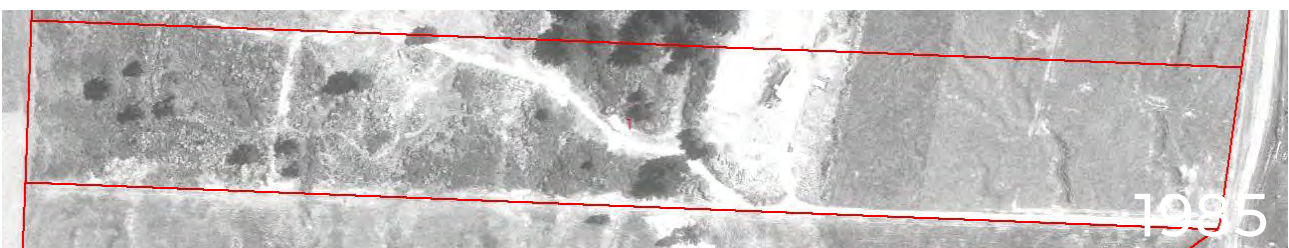
1985 - Small buildings / structures on boundary removed, possible cessation of fill activities in what was possibly former forestry. Sawmill remains, logs clearly visible in property north.

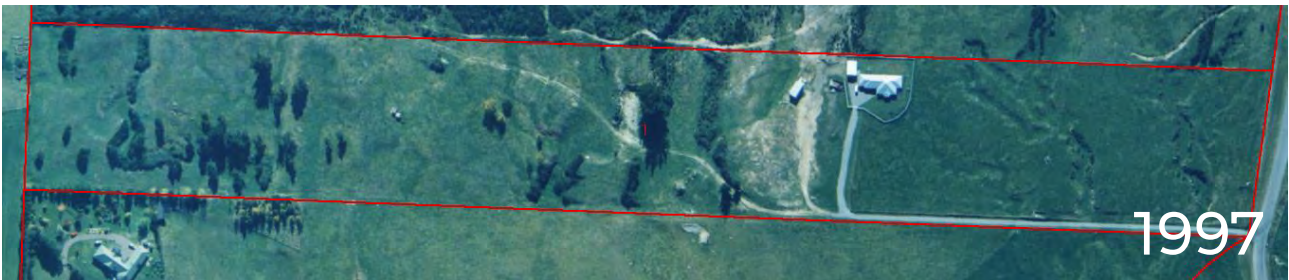
1997 - Site mostly pasture. One residential property present in a location just east of possible sawmill. Sawmill appears to have ceased operation, but building is still present with some evidence of plant distress in the immediate surrounding area.

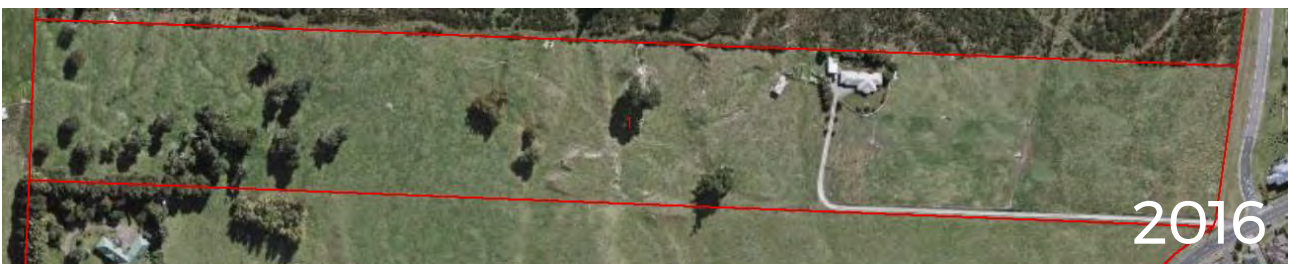
2004 to 2017 - Site pasture with residential property. Sawmill building remains, no visible signs of plant distress or land disturbance.

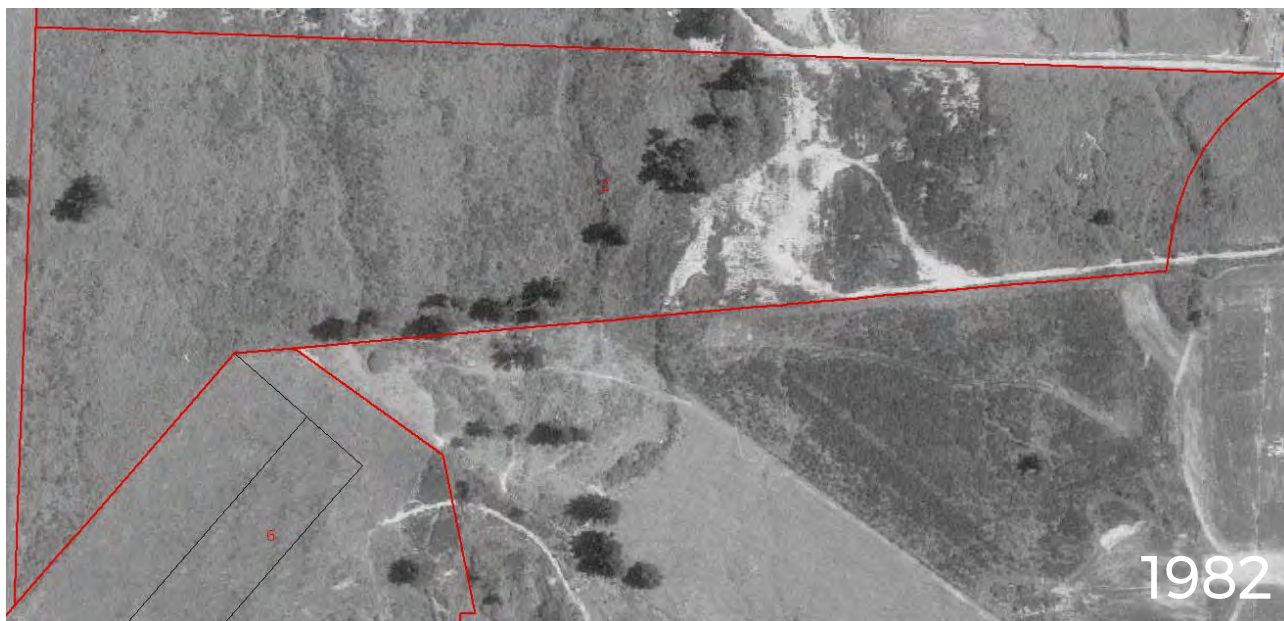
1982 and 1983 - Scrub / Bush. Some possible fill or just land disturbance.

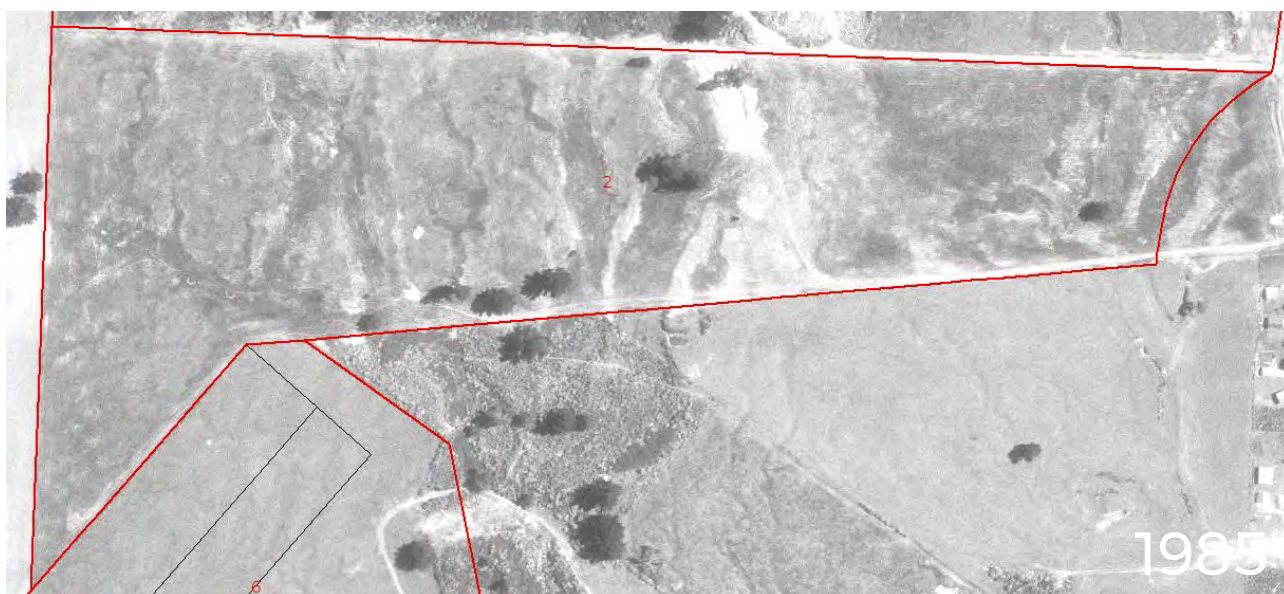
1985 - Scrub / Bush clearance. Some land disturbance in centre north of property from activities present in site 1.

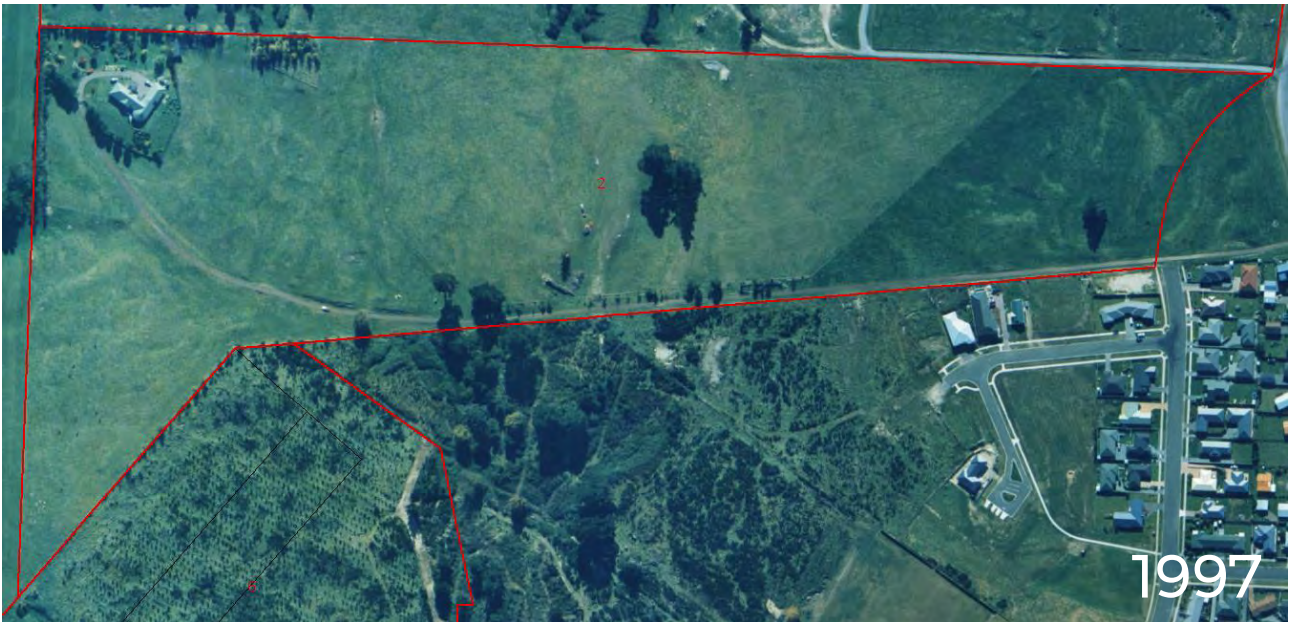
1997 to 2016 - Site pasture. Residential property is present in the north-west.

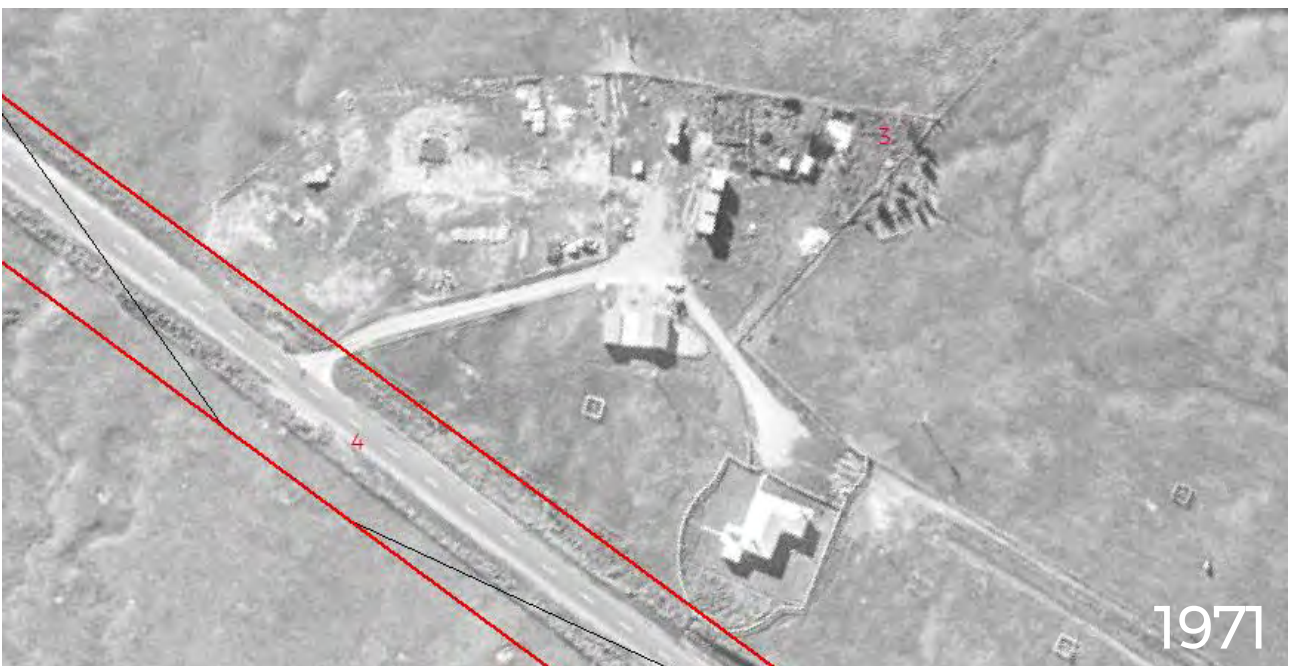
1971 – Farm / Pasture. Areas of land disturbance / machinery / unknown materials. Some storage sheds visible. Silage stacks present in centre north of the property.

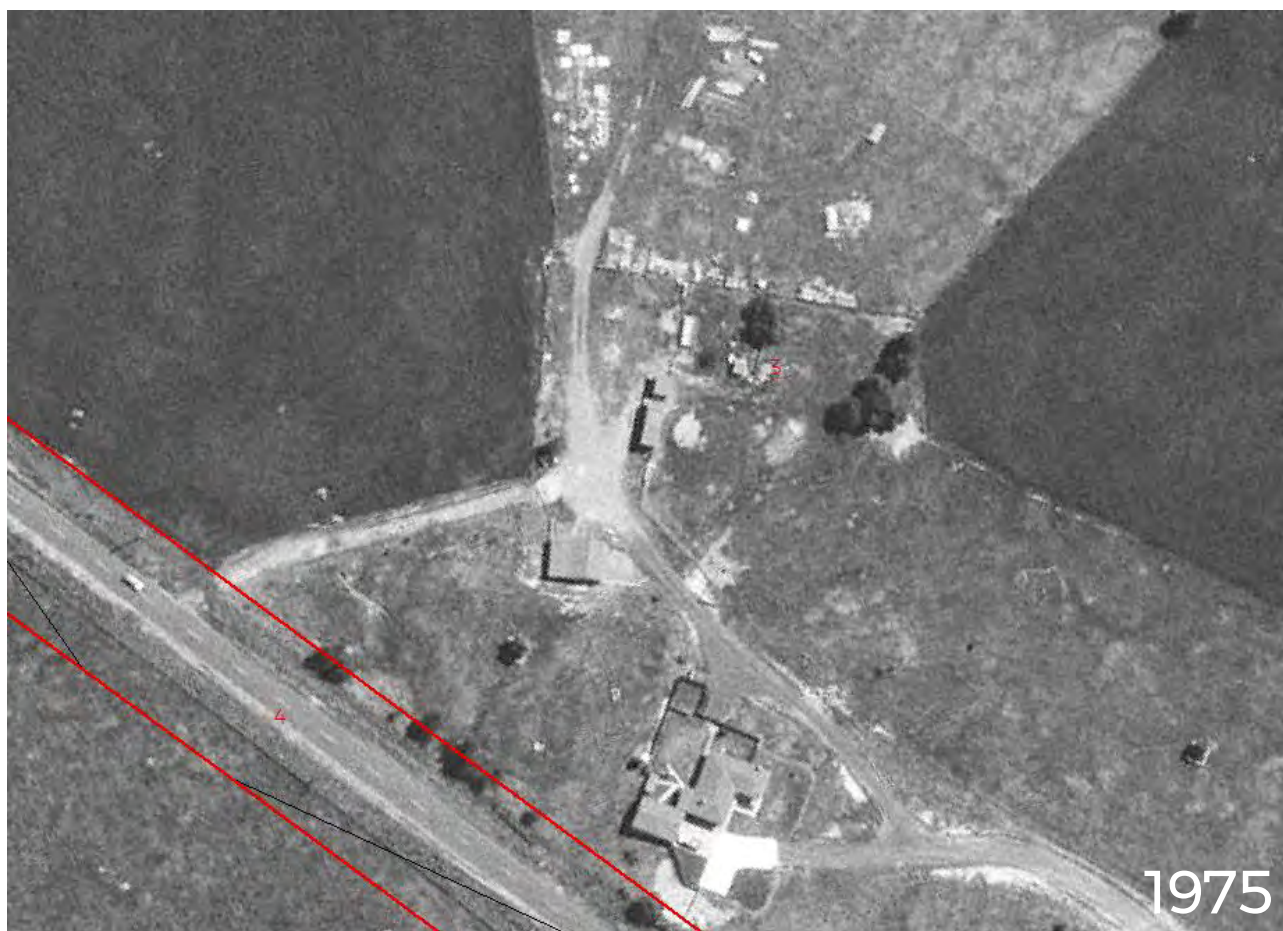
1975 – Farm / Pasture / Cropping Areas of land disturbance reduced, but machinery / unknown materials still present on property. Silage stacks present in centre north of the property.

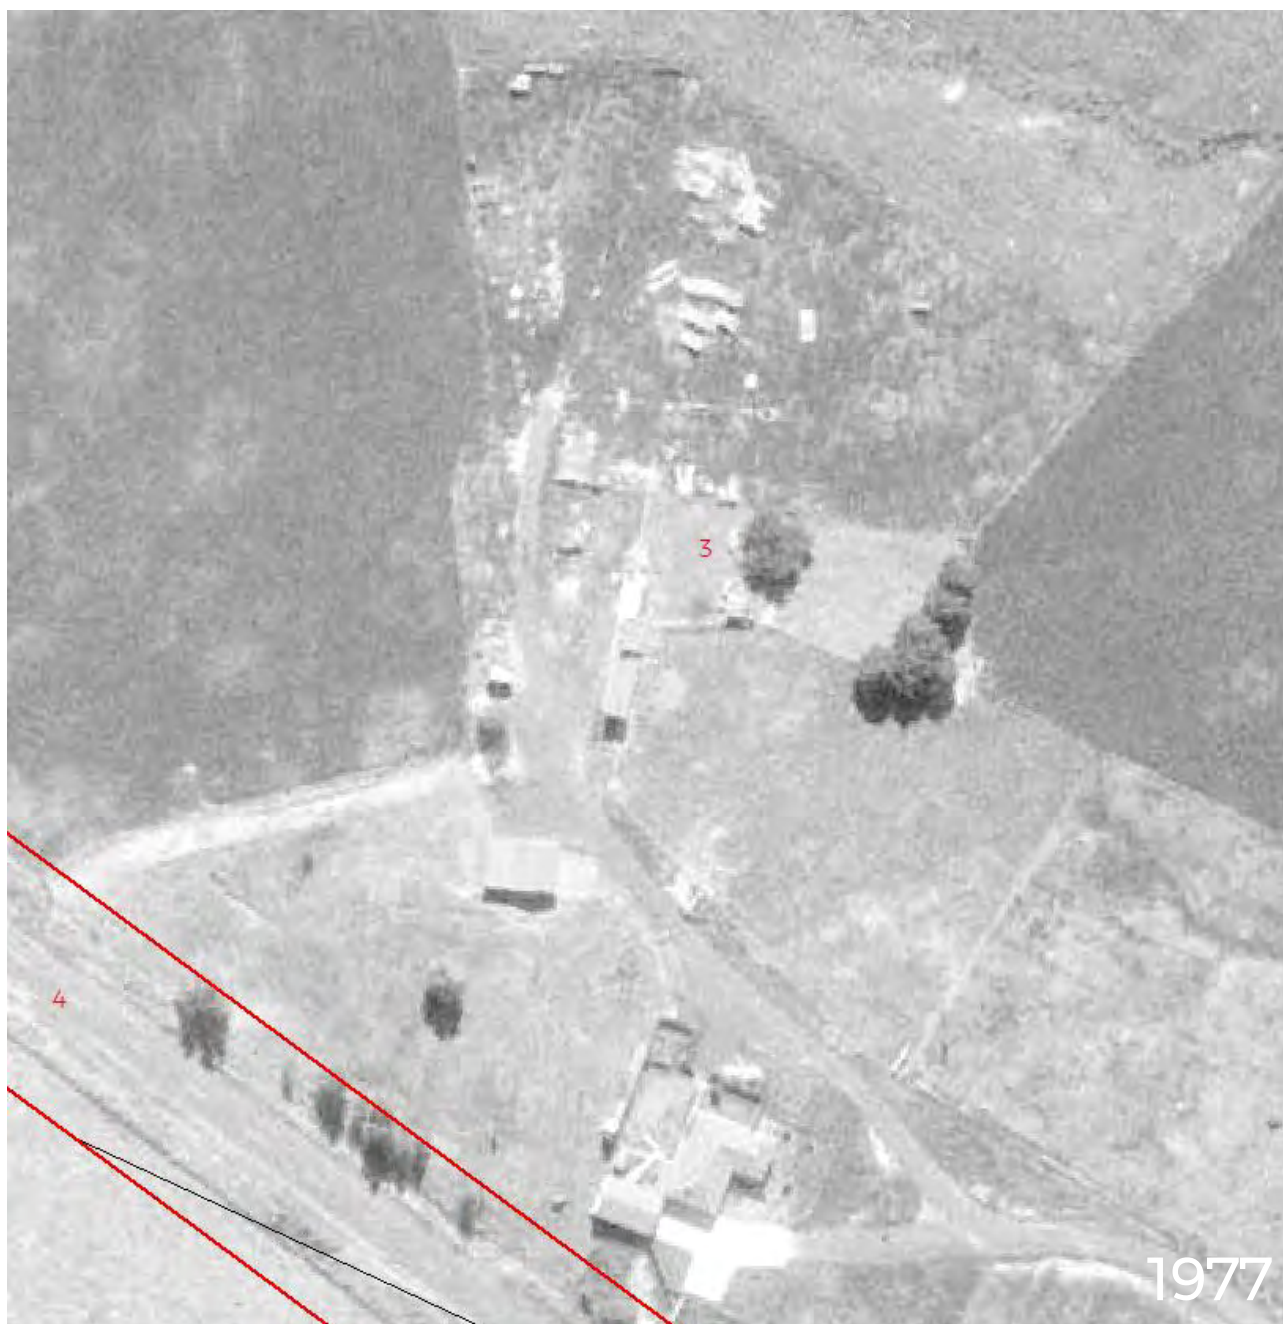
1977 to 1983 - Farm / Pasture / Cropping. Machinery / unknown materials still present on property. Silage stacks present in centre north of the property. There appears to be the beginnings of a horse exercise area in the 1983 imagery.

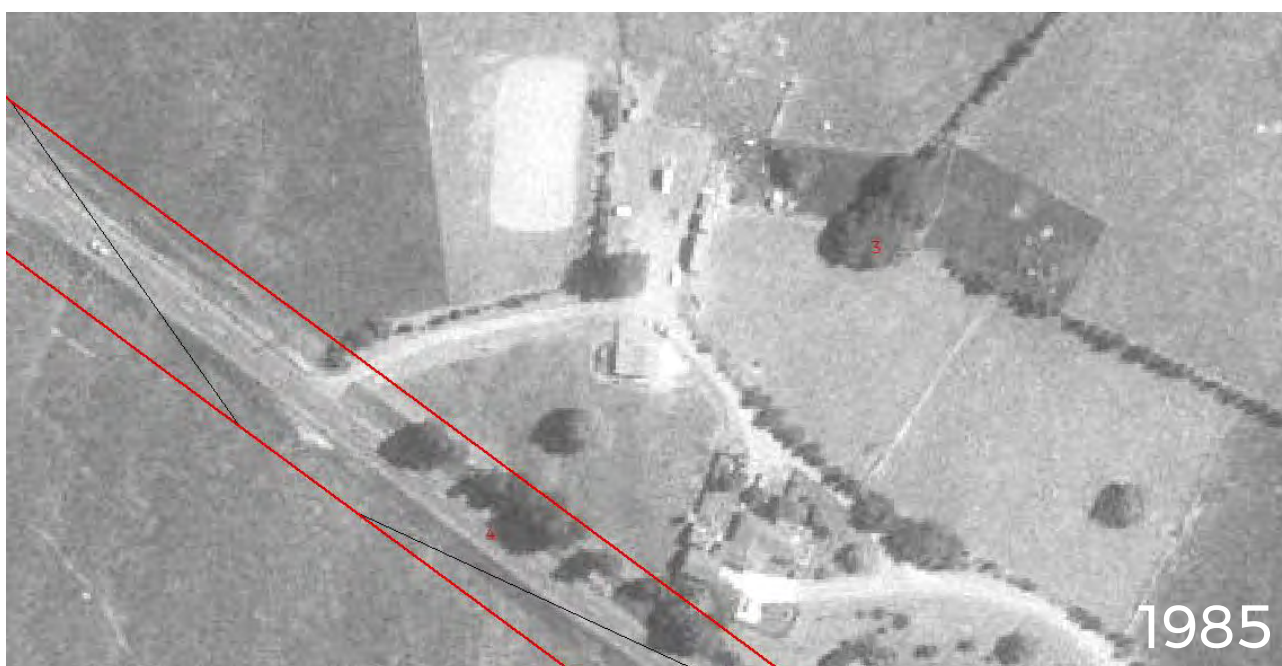
1985 - Farm / Pasture. Machinery / unknown materials reduced on property, couple of vehicles visible. Remains of silage stacks barely visible. What appears to be a horse exercise area is present.

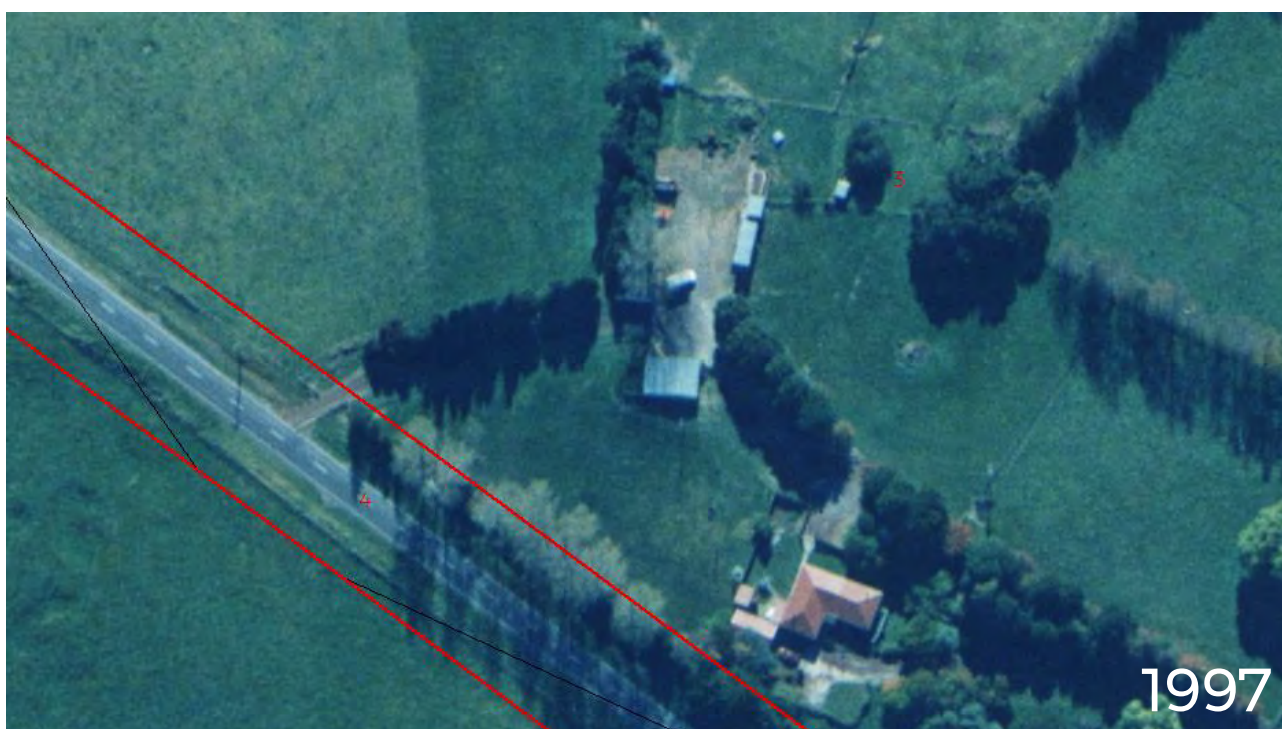
1997 to 2004 – Site is farm / pasture with rural residential.

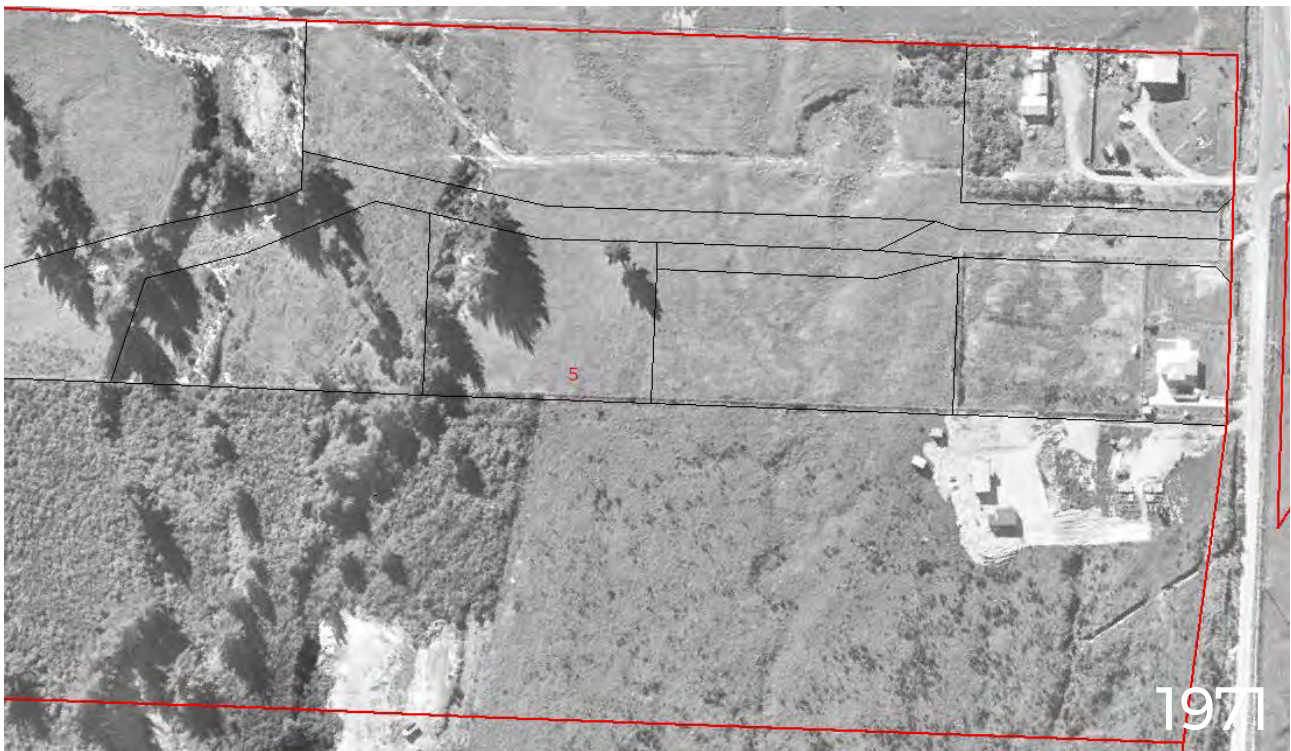
1971 – Scrub / Bush. More residential properties in the north-east corner. Land disturbance as a result. Some land disturbance / fill as a result of activity from site 1 over spilling into property.

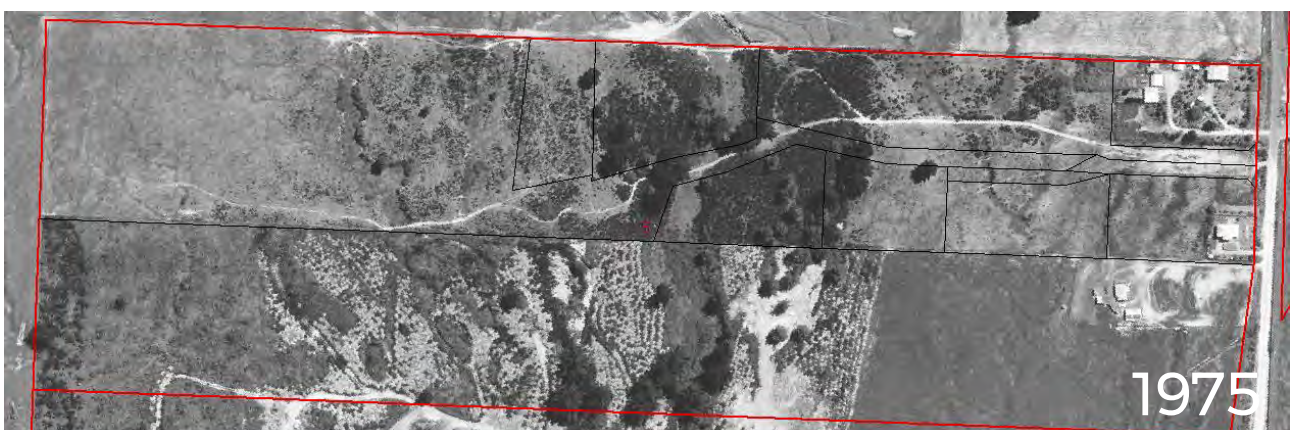
1975 – Residential to north-east corner. Forestry to south-west – overflow from site 1. Remainder scrub / pasture.

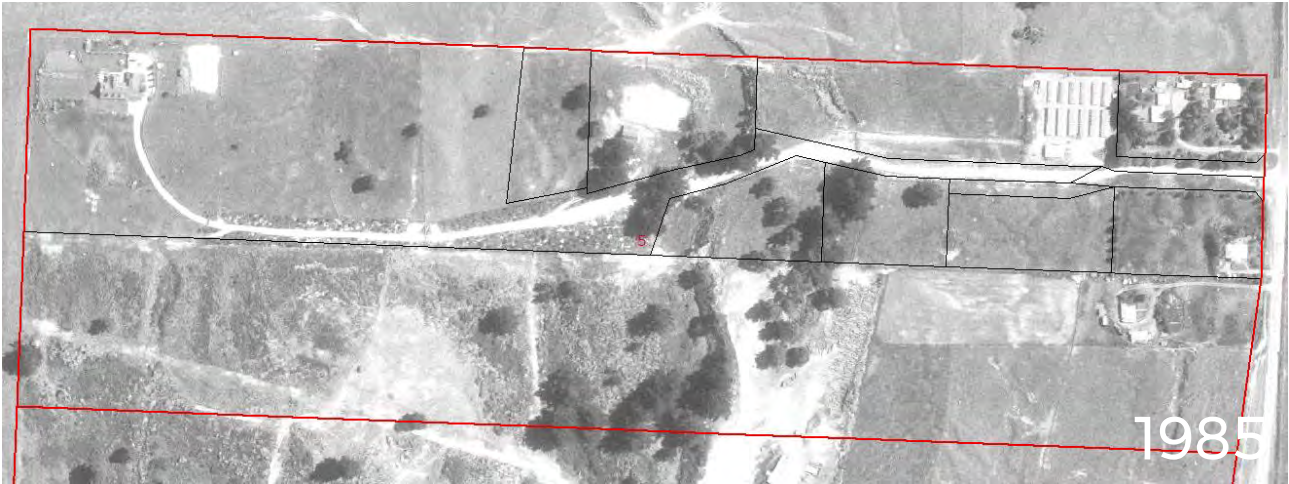
1985 - Residential to north-east corner, what appear to be greenhouses are still present. Property to the northwest, redevelopment over small orchard. Remainder of northern half remains pasture, with some land disturbance in the centre north and possible farm shed. Scrub / bush to south-west with land disturbance / fill activities from area 1 encroaching. Appears to be log storage in the centre south of the site.

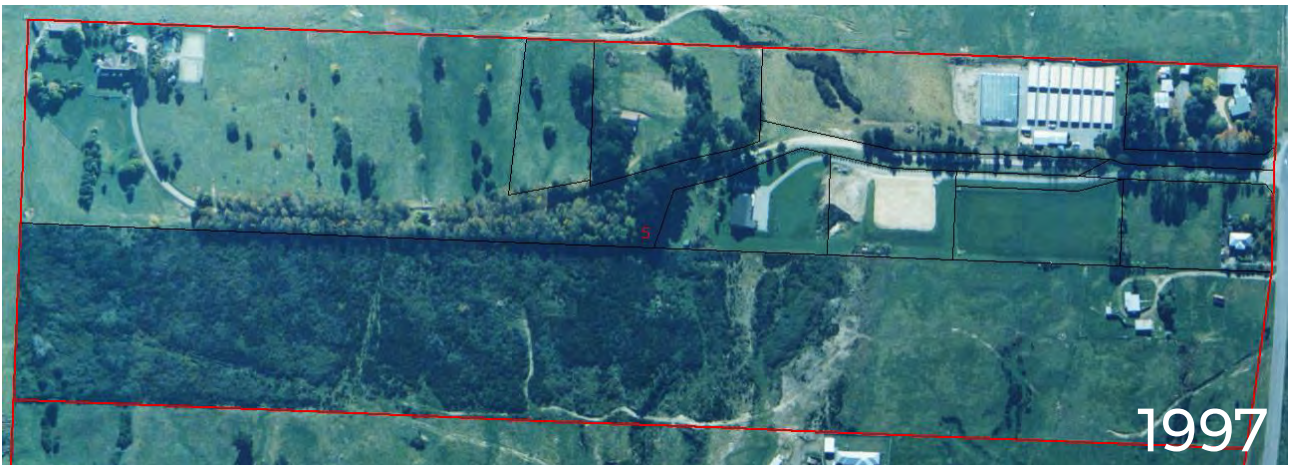
1997 - Glass houses and residential visible to north-east, single residential property to north-west. Some land disturbance in centre of site just east of a new residential property, looks to be foundation work for new buildings. Area previously identified in 1985 as land disturbance has clearly been levelled and still has building to south of it. Southern half is mixture of scrub / bush and pasture.

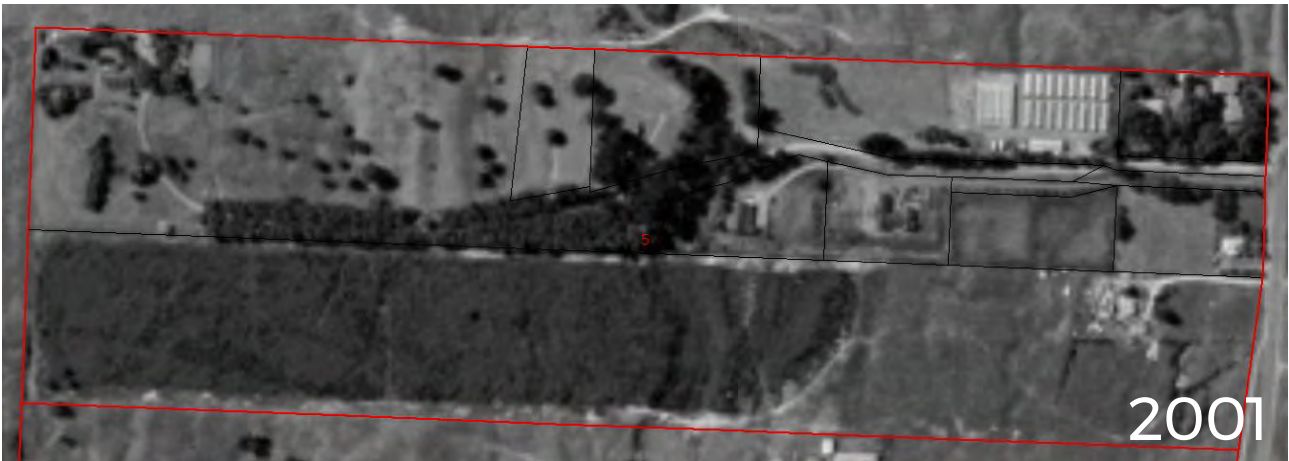
2001 - Expansion of greenhouses to north-east, two more residential properties in the centre of the site. Land disturbance in the centre north is now re-grassed and possible farm shed remains. Southern half of site appears to have scrub / bush regeneration.

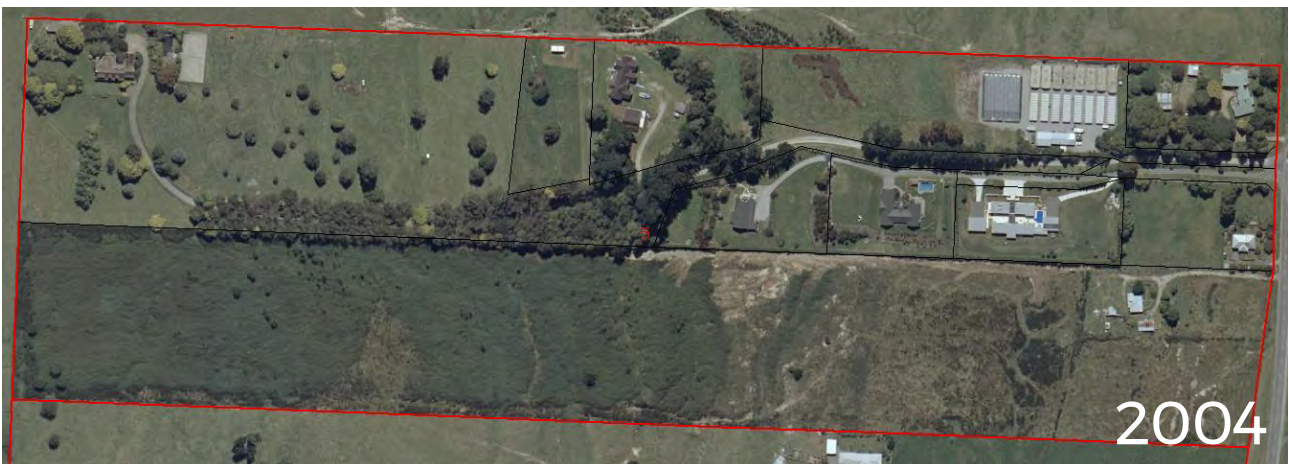
2004 - As 2001, but with additional residential properties (including one on previously levelled section). Some land disturbance towards the centre of the site.

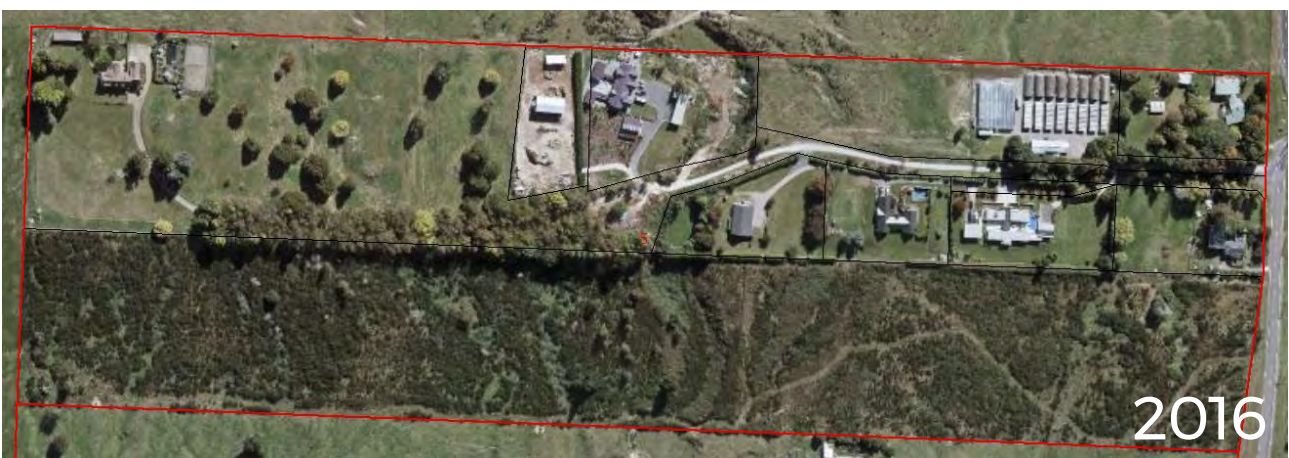
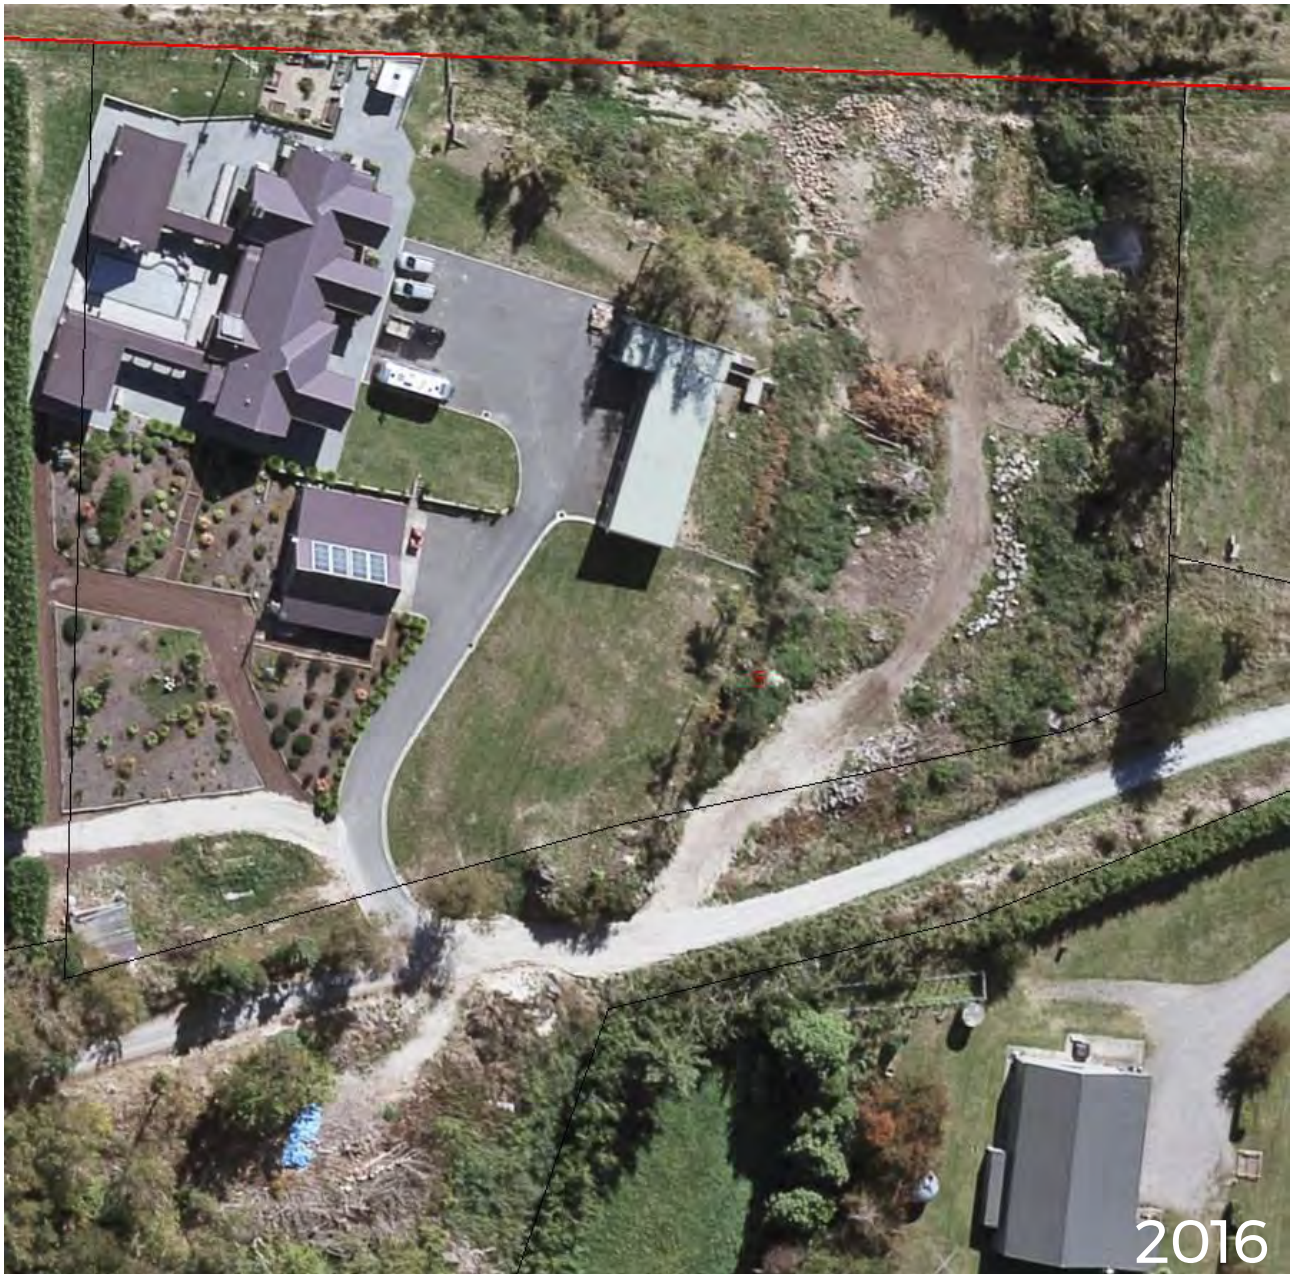
2016 - Further residential development and associated land disturbance and fill / storage of materials in the centre north of the site. Southern half has scrub / bush regeneration.

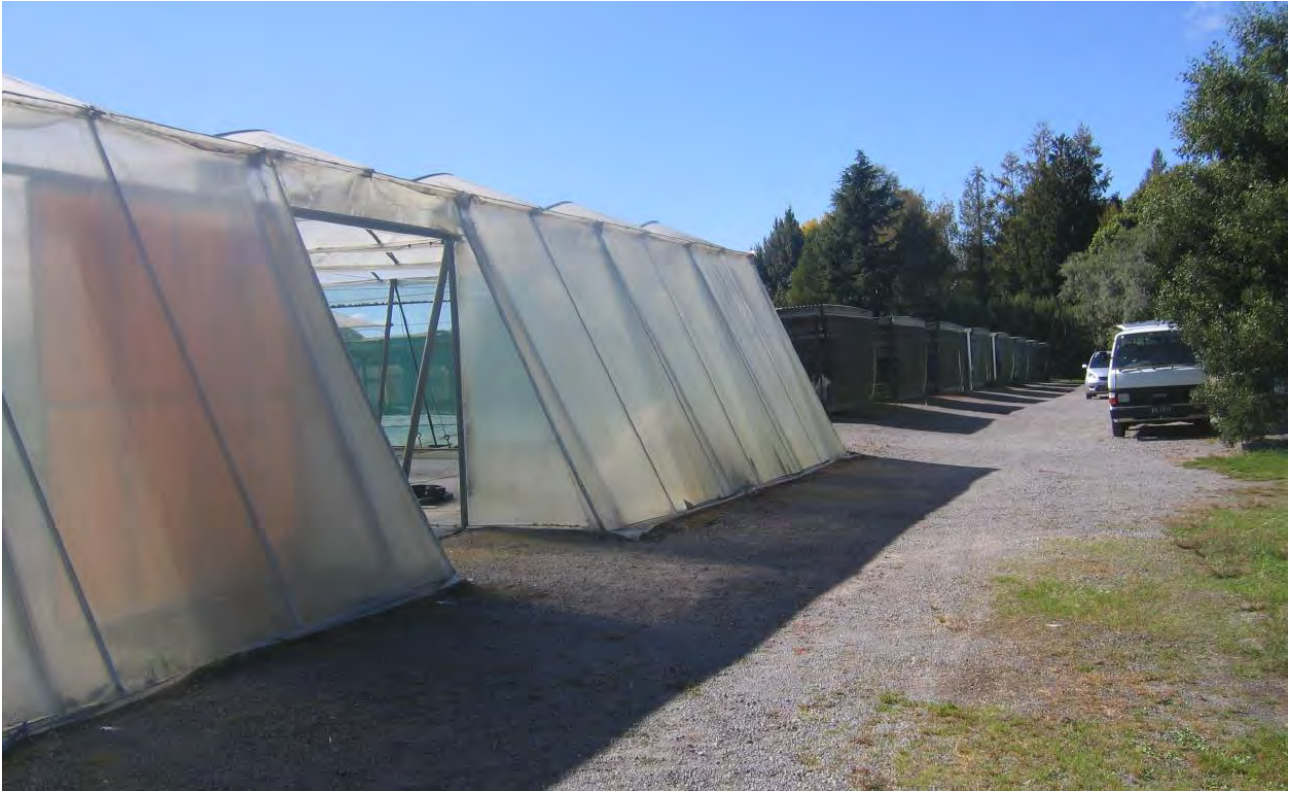
Photo 1 - Image from property file (date unknown)

Date unknown - Photo 1 showing glasshouse activities.

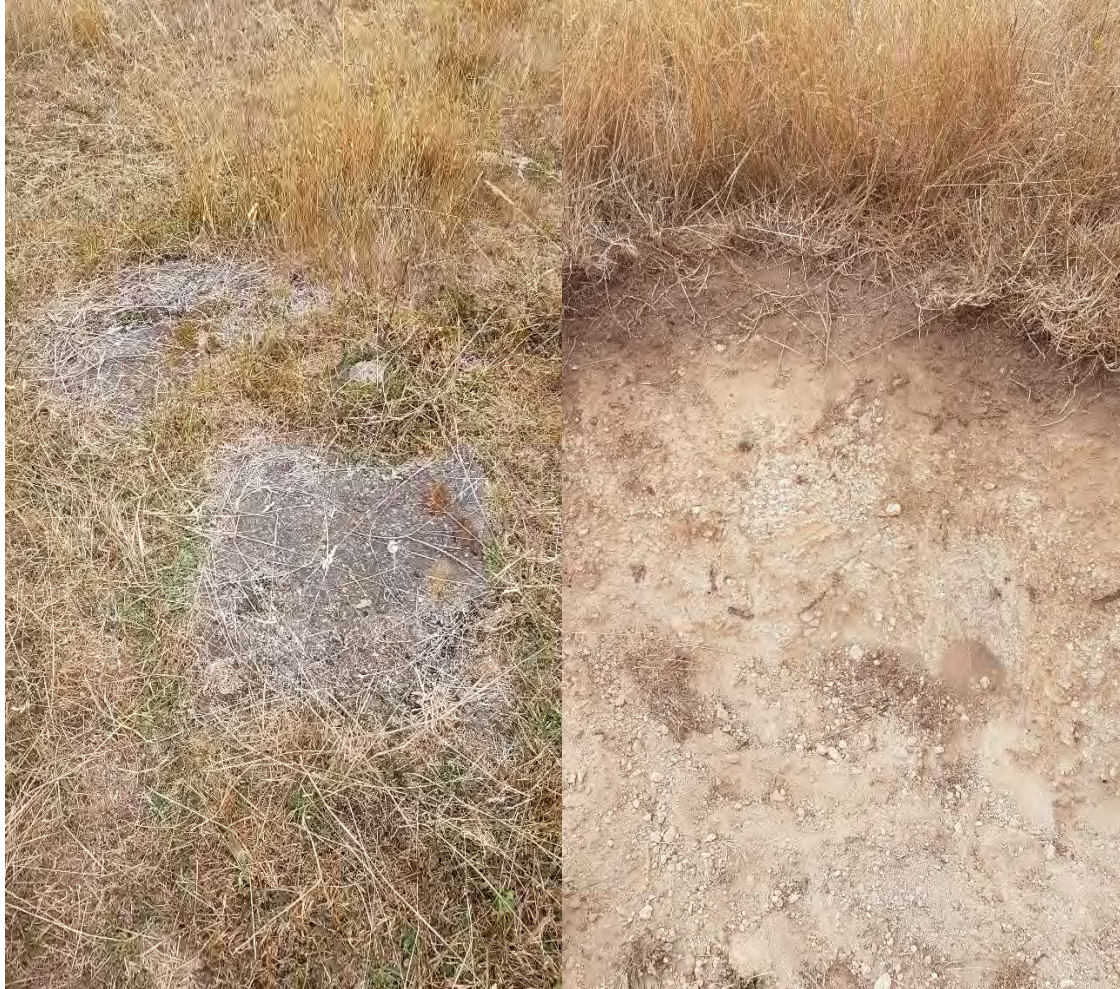
Concrete footings (left) and exposed natural ground (right)

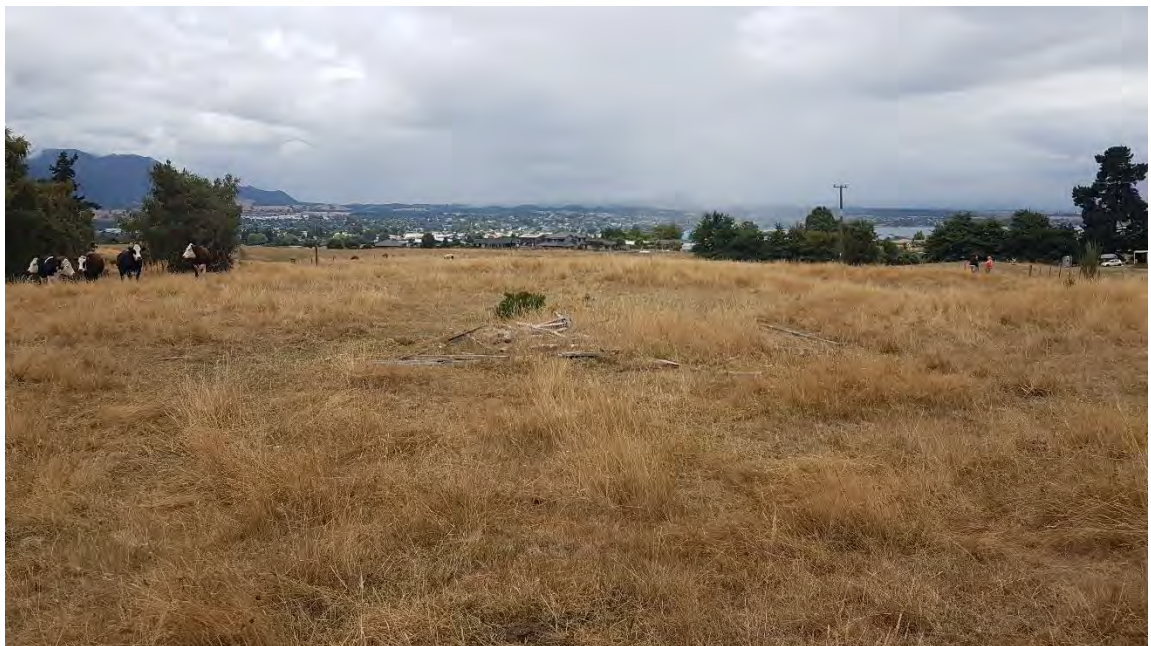
Timber remains

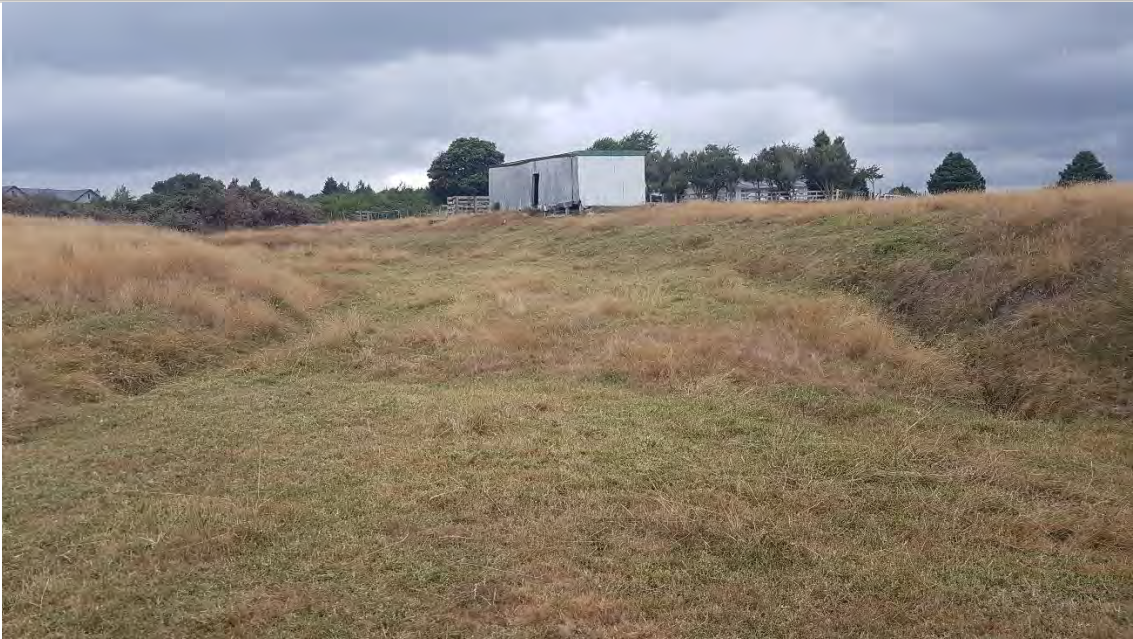
<p>Possible filled gully adjacent to old shed</p>
