Project Number: 2-37400.00

Nukuhau Structure Plan

Geotechnical Report

27 October 2020

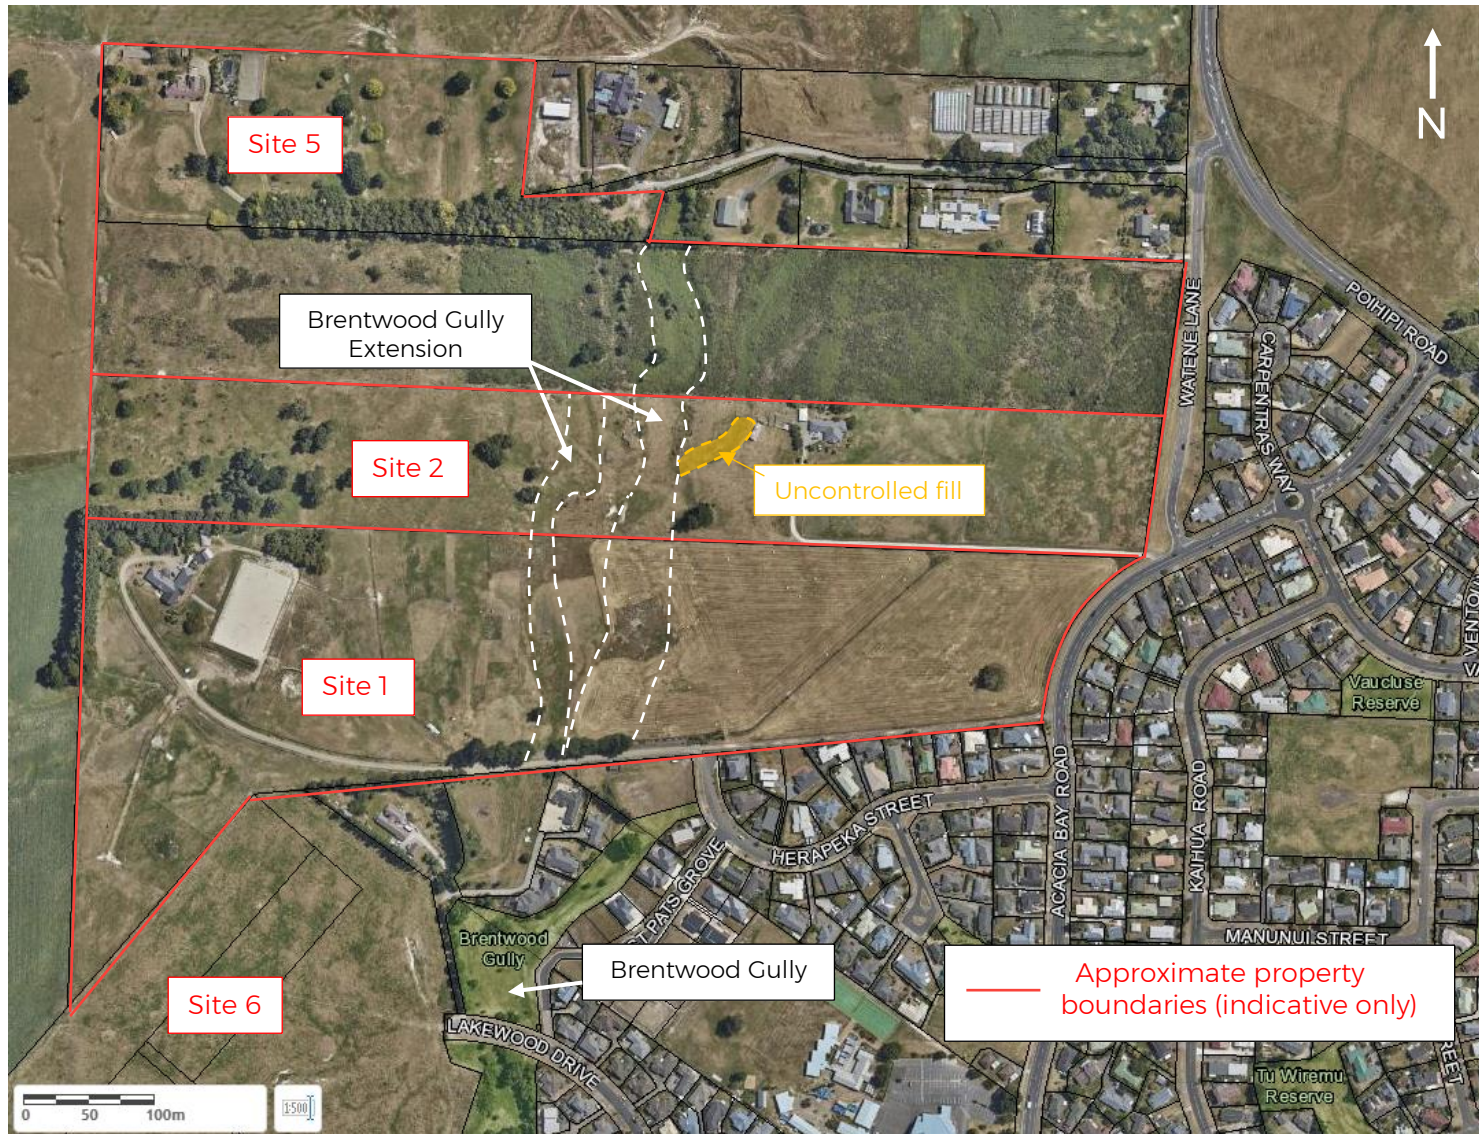
Figure 4: Sites 1, 2, and 5 (outlined in red). Background image taken from TDC's Mapi Service

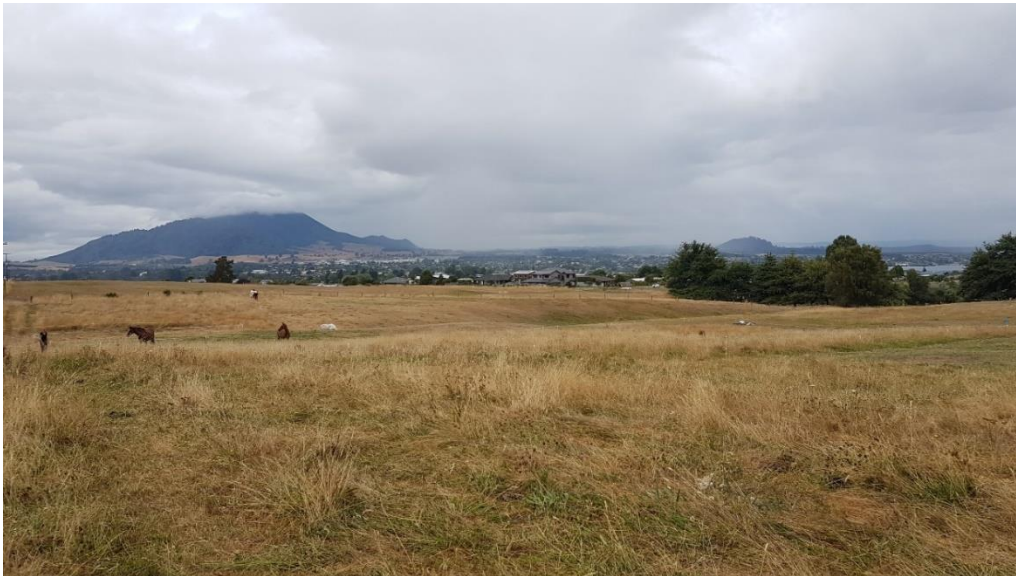
Figure 5: Site 1 general overview, looking southeast

Sites 1 and 2 (Figure 4, Figure 5, Figure 6, Figure 7, and Figure 13):

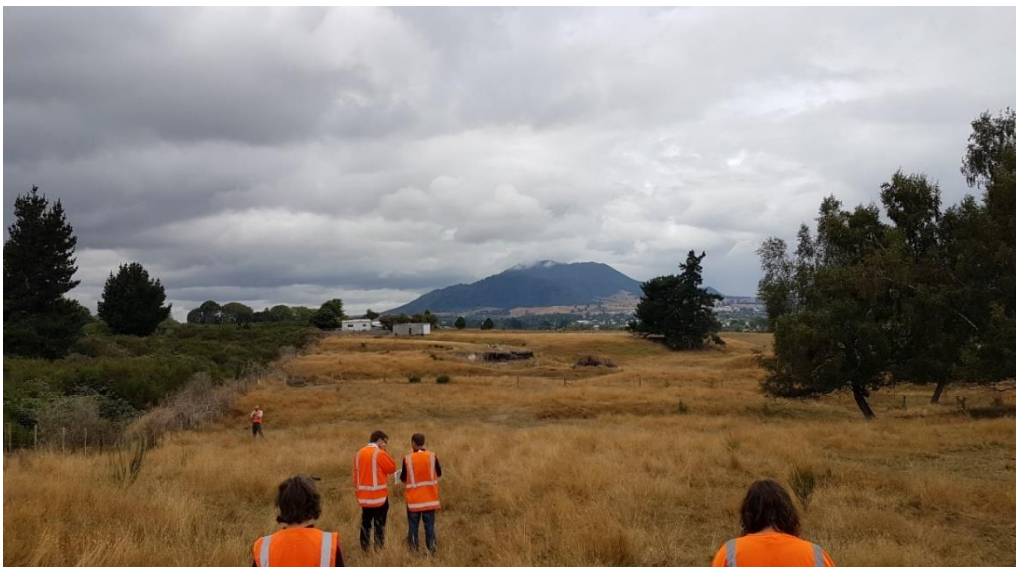
Figure 6: Site 2 general overview, looking east

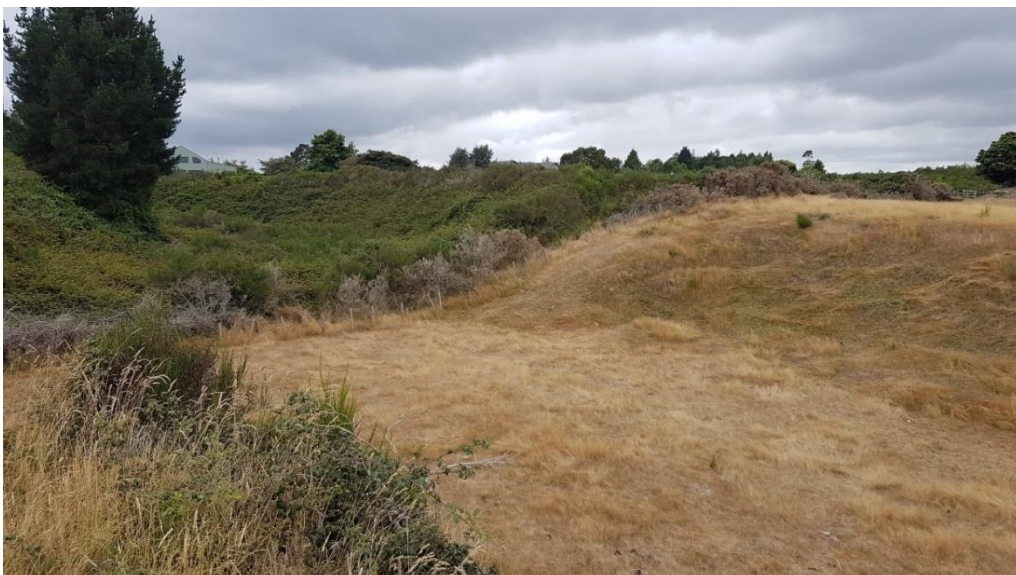
Figure 7: Large gully on Site 2 (extension of Brentwood Gully)

No evidence of areas prone to flooding issues, including areas of ponding, were encountered during the investigations. Flooding may foreseeably be an issue in the Brentwood Gully Extensions identified in Figure 4 where higher stormwater flows could be expected during storm events. For this reason, it is recommended to avoid development in these areas without further hydrologic studies.

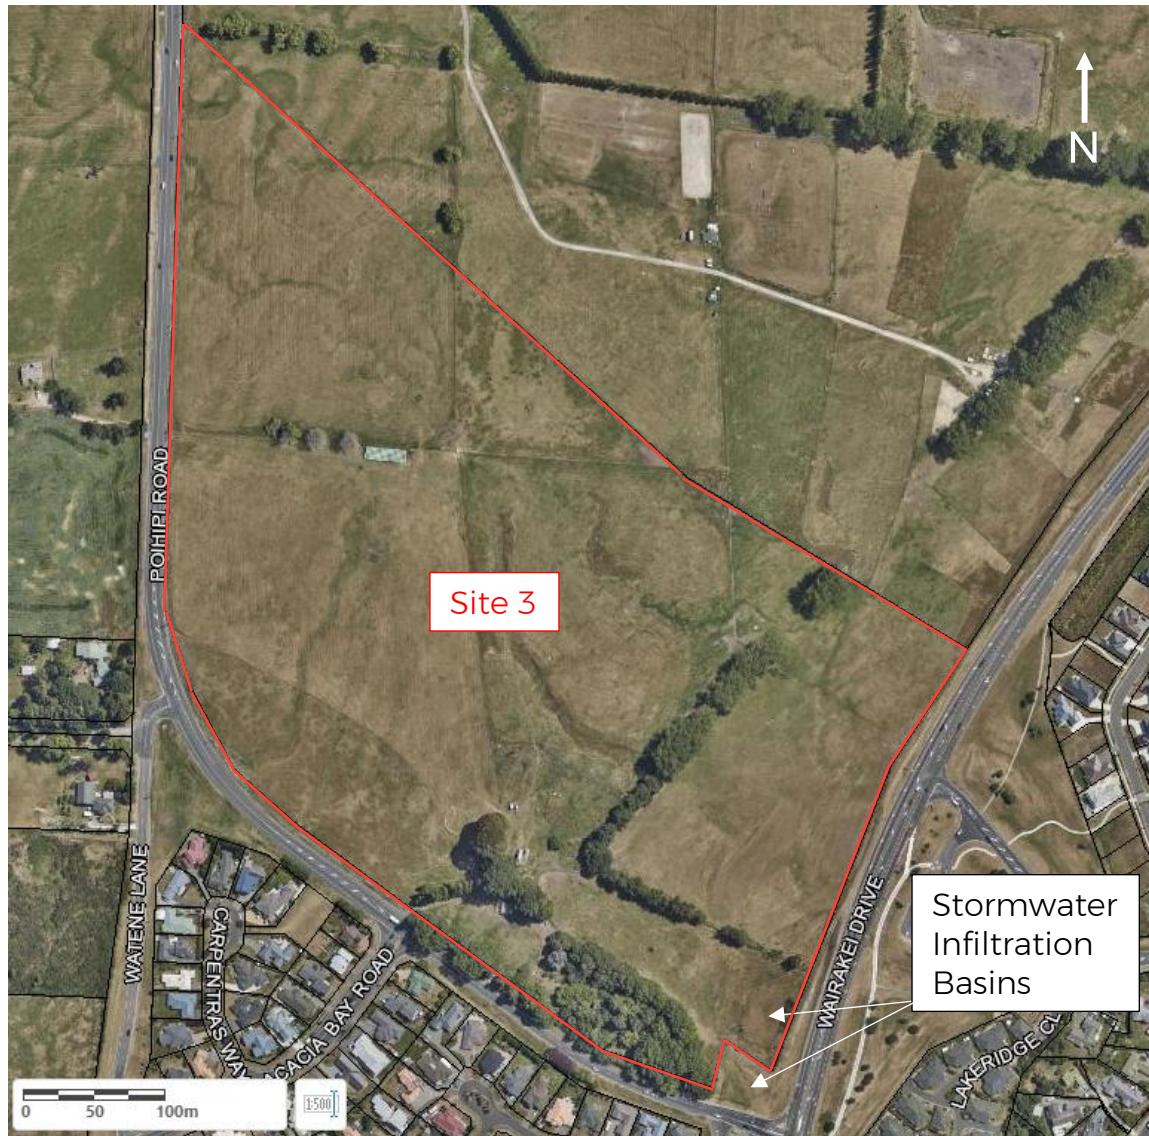
Figure 8 - Site 3 (outlined in red). Background image taken from TDC's Mapi Service.

Site 3 (Figure 8, Figure 9, and Figure 10):

- Dwellings should be provisionally offset at least 10 m from any steep-sided gullies such as the Brentwood Gully extension shown in Figure 4 and the stormwater infiltration basins in Site 3, shown in Figure 8, in order to reduce the risk to dwellings from potential slope instability. It should be noted that subsequent detailed civil design may overrule this requirement if the landform is sufficiently modified and/or retained.

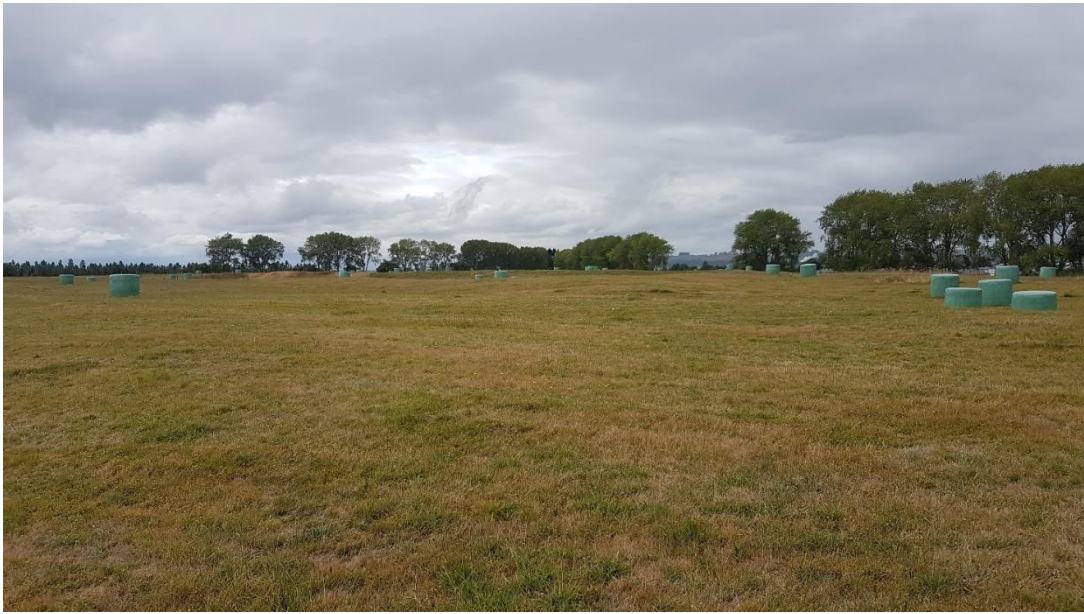
Figure 9: Site 3 general overview, looking northeast

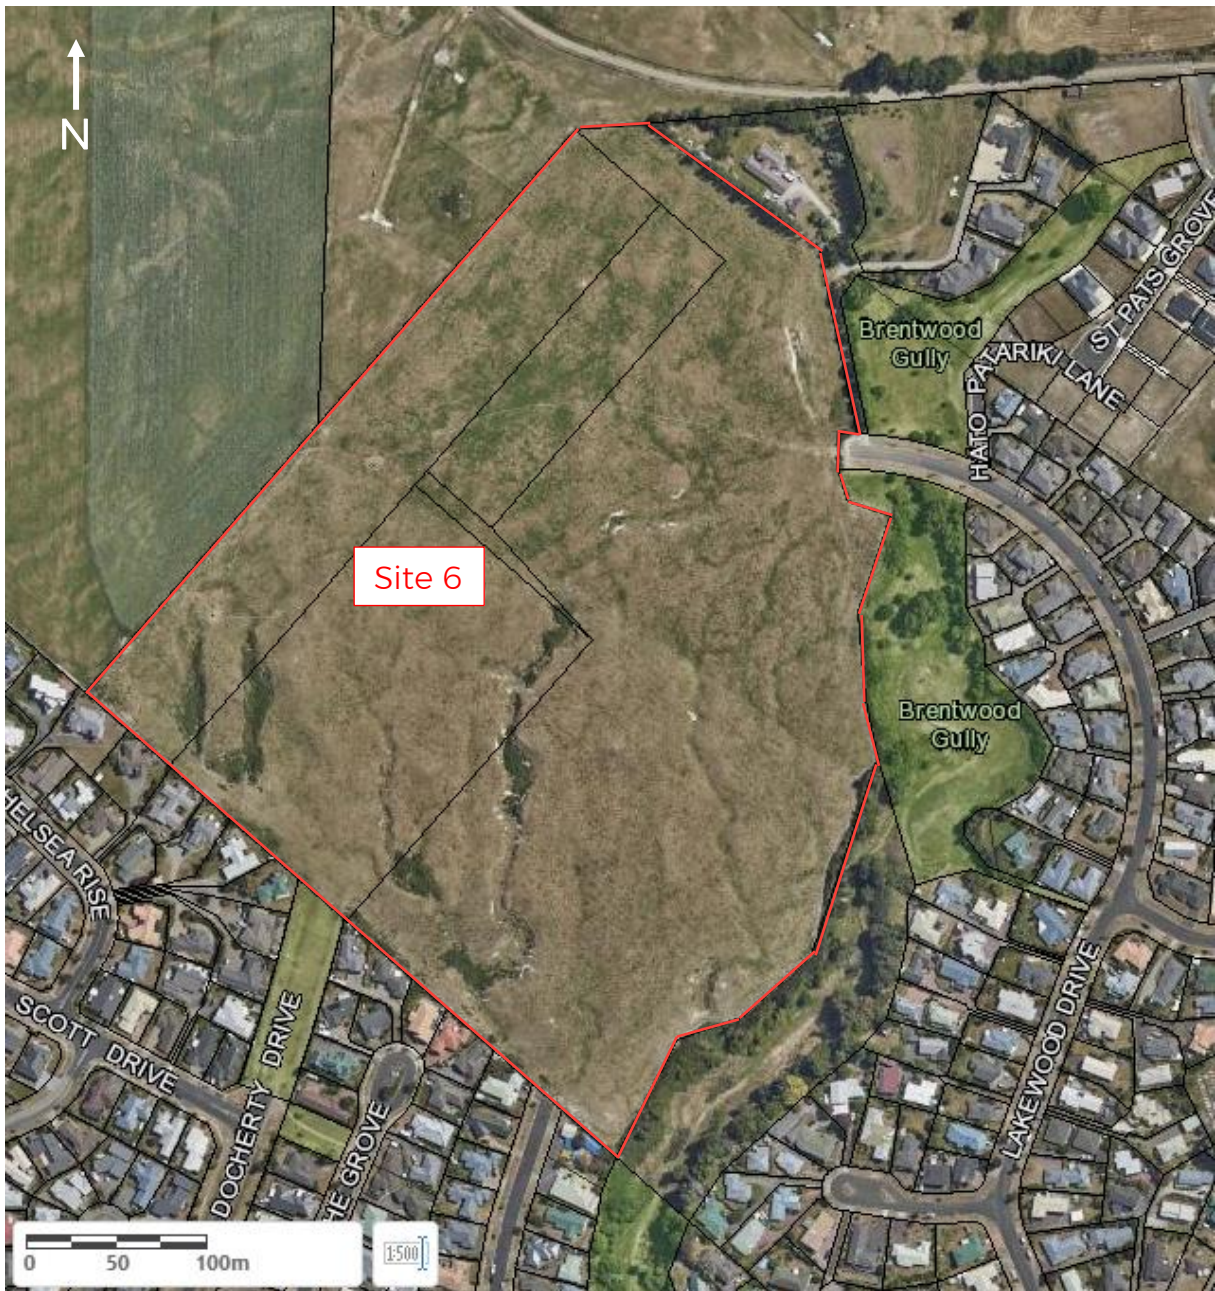
Figure 11: Site 6 (outlined in red). Background image taken from TDC's Mapi Service. NB Gullies throughout site.

No hand augers were conducted at Site 6. An outcrop of white pumice sand was observed in a gully running down the centre of the site and could generally be described as ‘fine to coarse poorly graded SAND with some subangular pumice gravel; white; dry;. Crushes to fine to coarse sand with minor gravel. [TAUPO PUMICE FORMATION]’.

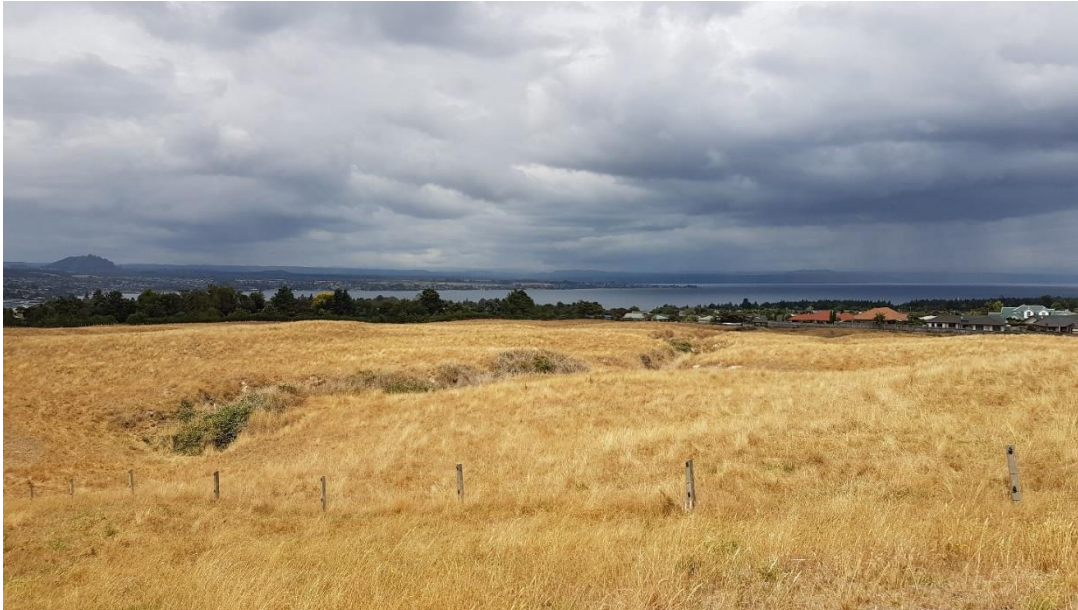
Figure 12: Site 6 general overview, looking southeast. NB gully at centre.

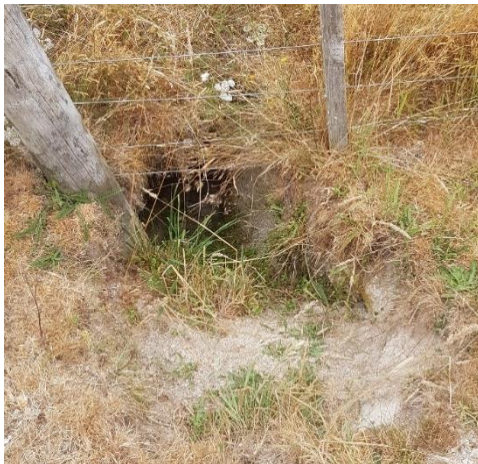
Figure 13: Tomo on fenceline between Sites 1 and 2

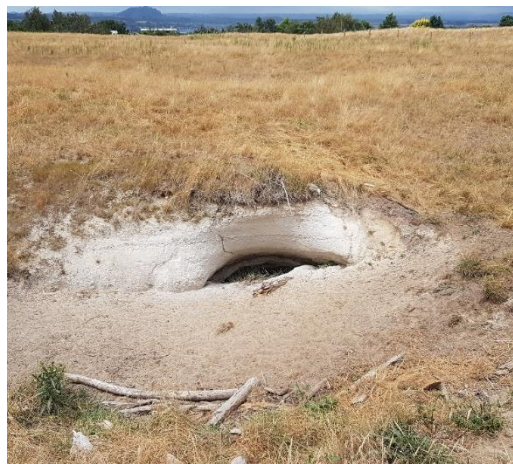
Figure 14: Tomo in gully on Site 6

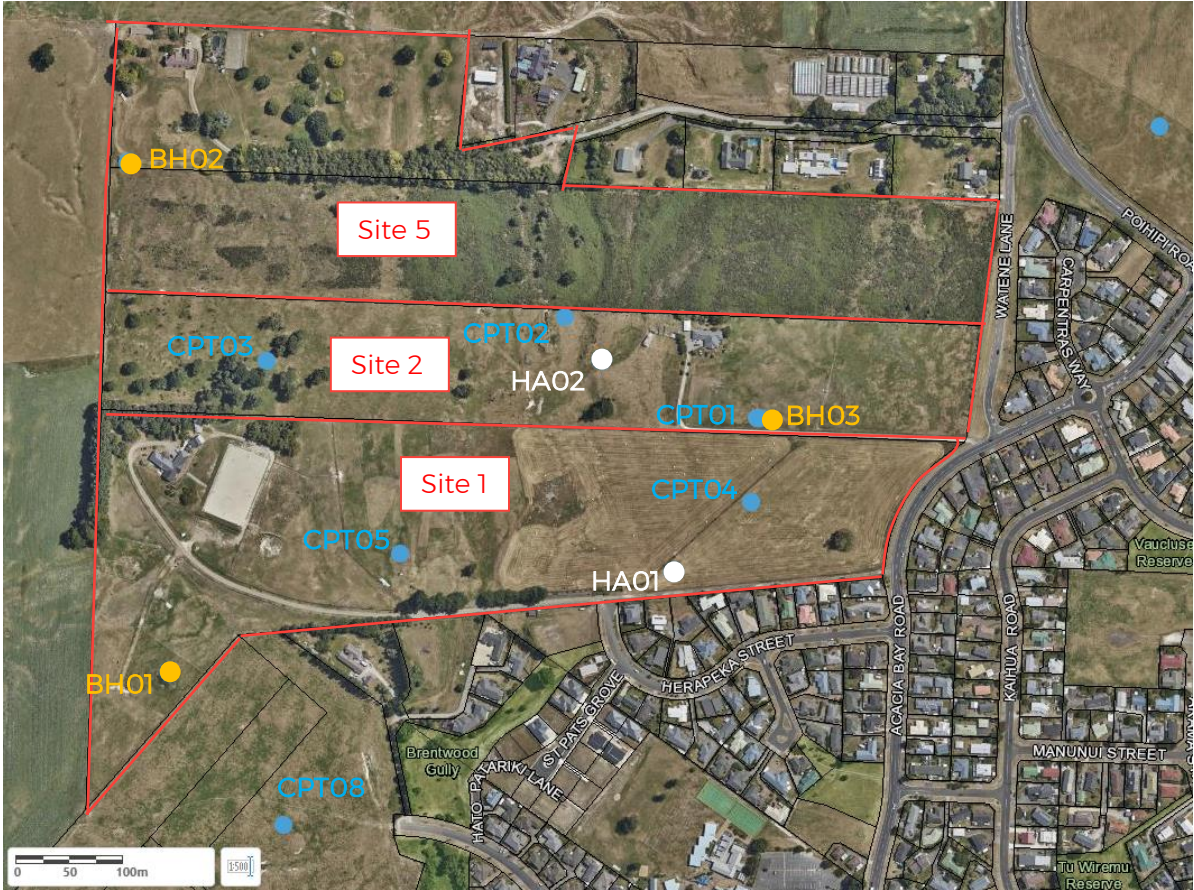
Figure 15: Investigation Locations - Sites 1, 2, and 5

Intrusive geotechnical site investigations were undertaken to assist in providing recommendations for development suitability. Investigations consisted of a combination of Cone Penetration Tests (CPTs), rotary core boreholes, and shallow hand augers. The investigation locations are shown on the plans in Figure 15, Figure 16, and Figure 17.

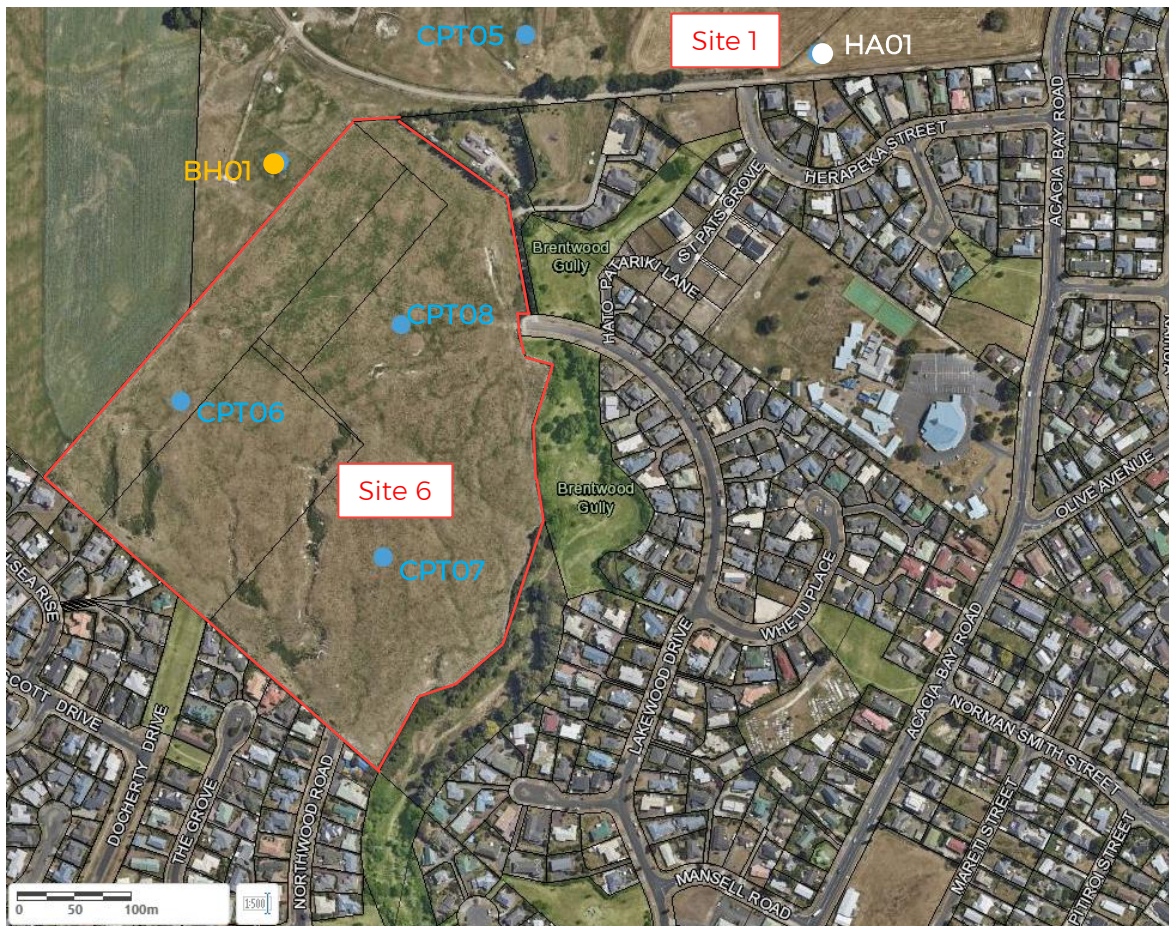
Figure 16: Investigation Locations - Site 6

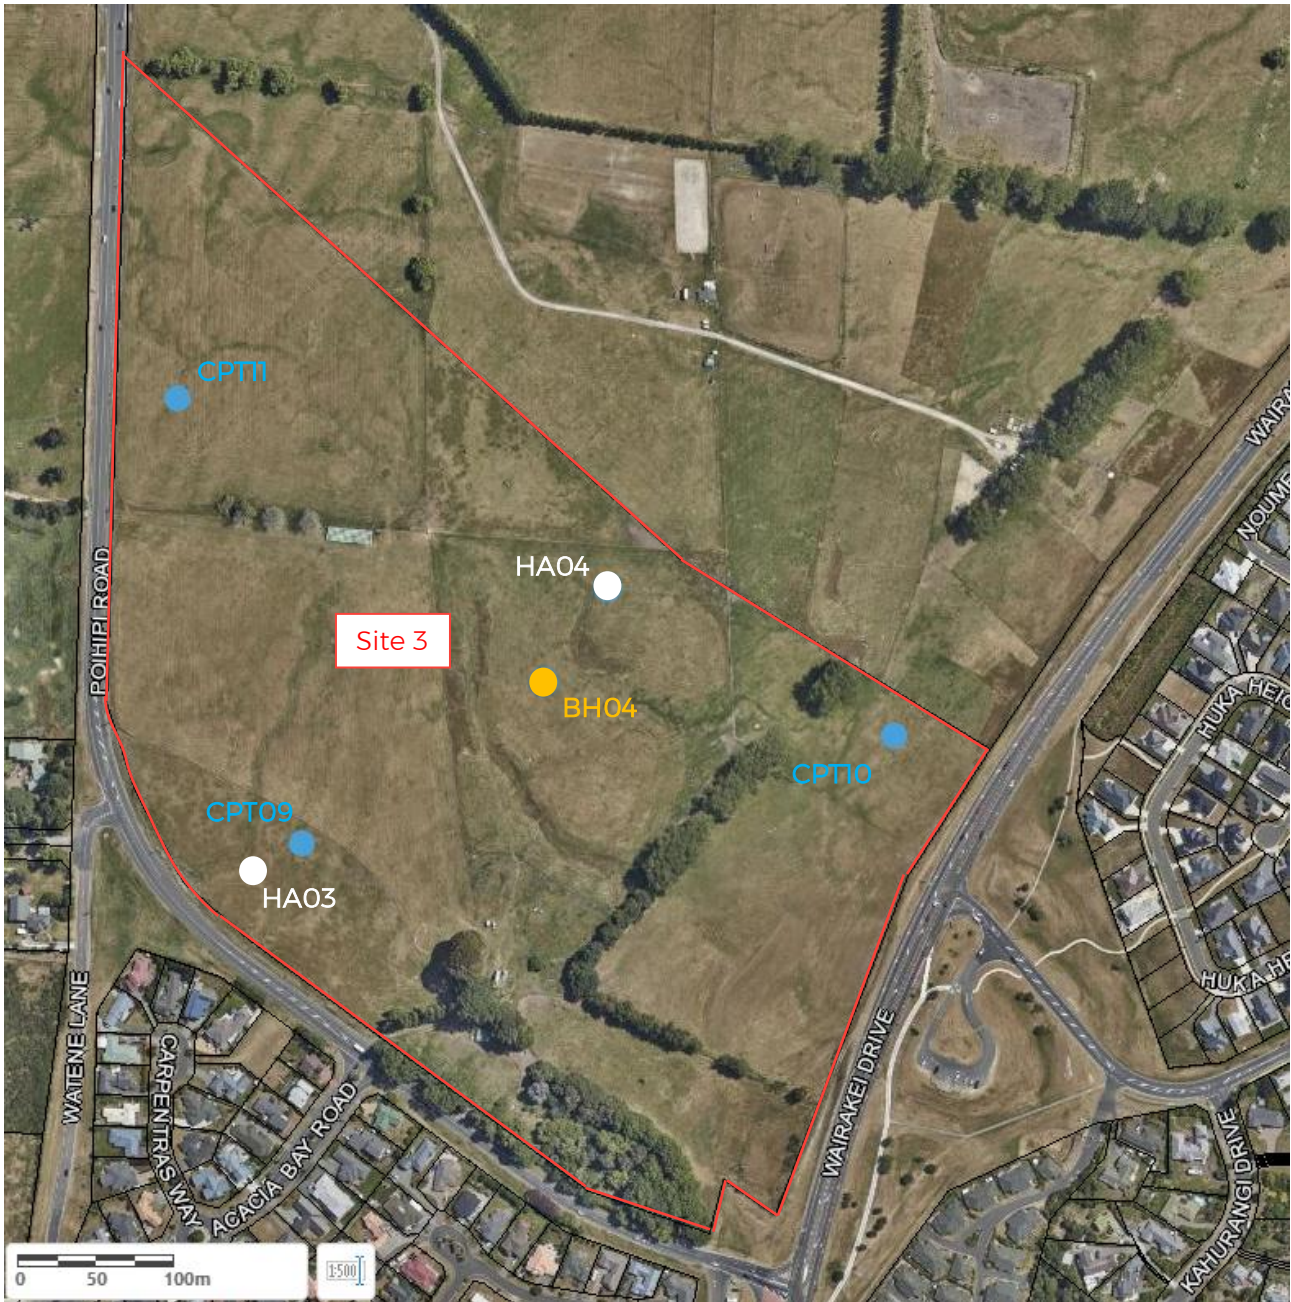
Figure 17: Investigation Locations - Site 3

Two hand augers (HA03 and HA04) were conducted to a depth of 1.0 m bgl at the approximate location shown in Figure 17. No outcrops were observed at this site. The hand augers both encountered material that was generally consistent with the Taupo Pumice Formation.

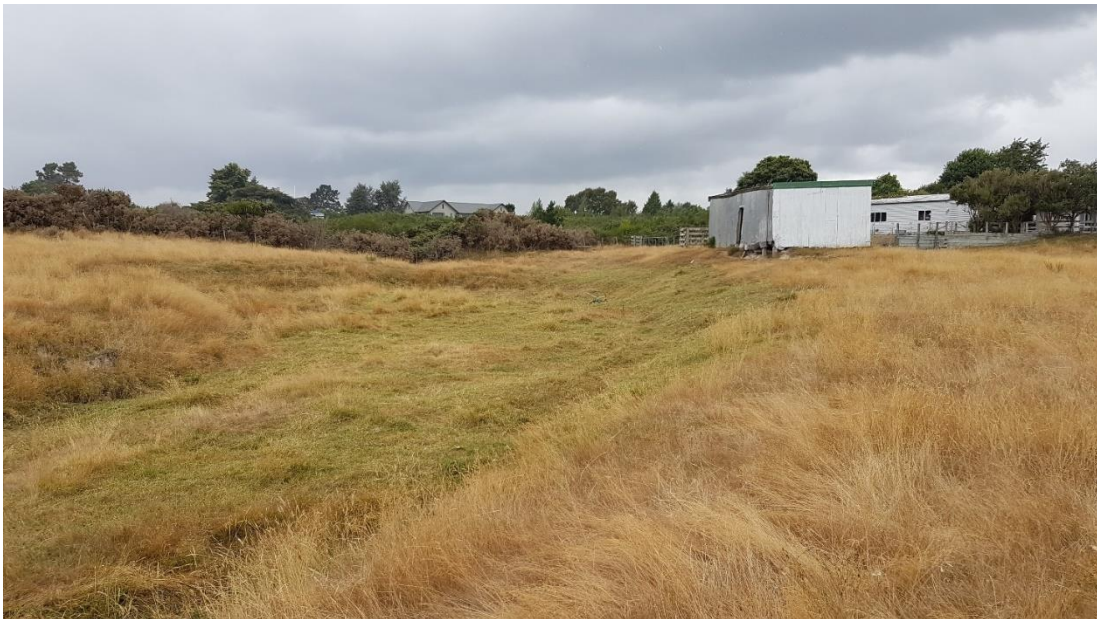
Figure 18: Filled gully on Site 2

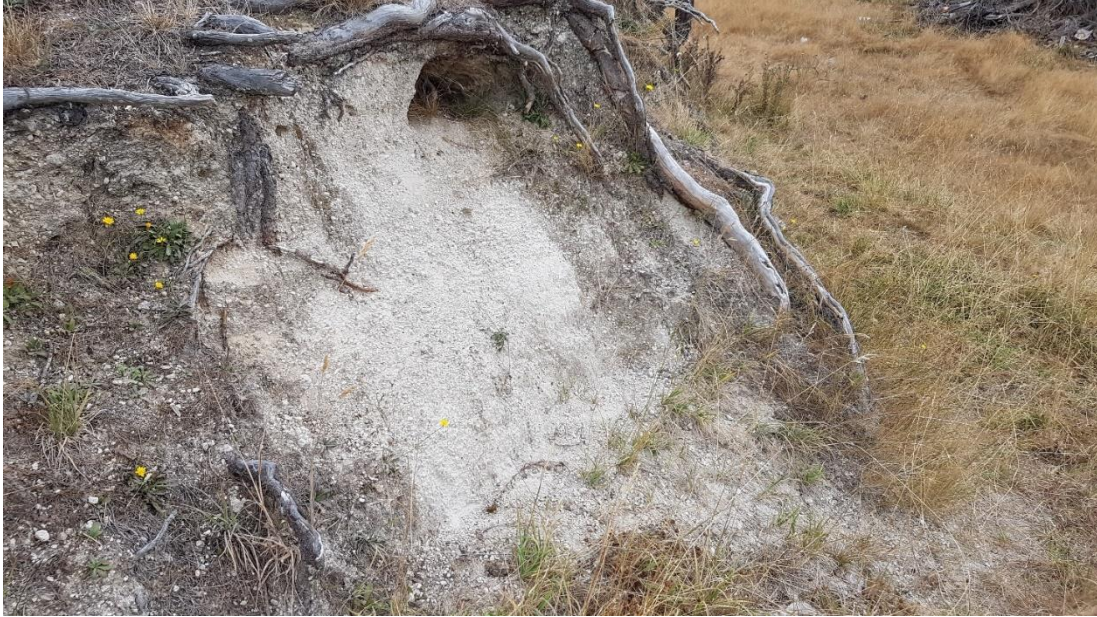
Figure 19: Pumice sand outcrop on Site 2

An outcrop of pumice sands was observed at the western end of Site 2 (Figure 19) and could generally be described as 'fine to coarse SAND with some gravel; white; dry; poorly graded; gravel, subangular pumice. Crushes to fine to coarse sand with minor gravel. [TAUPO PUMICE FORMATION]'

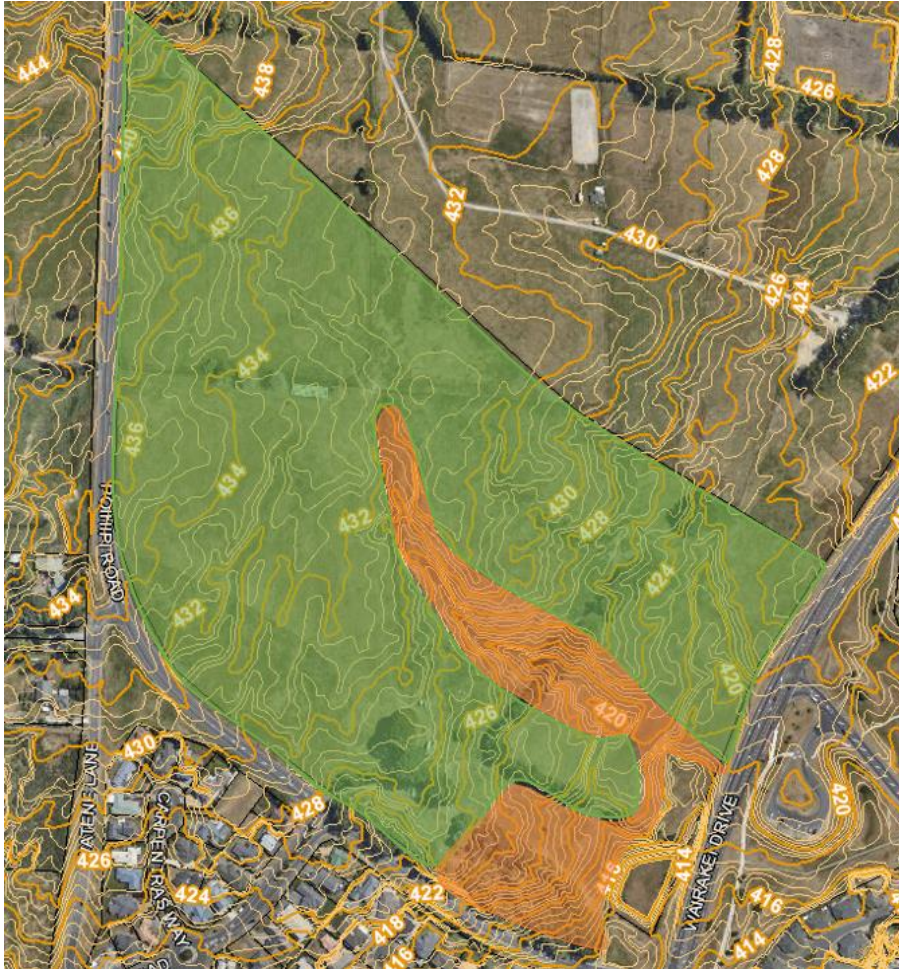
Figure 20: Indicative estimated cut and fill depth areas at Site 3 (green = estimated 1-2m, orange 2m+)

Bulk earthworks in the form of cutting and filling will likely be required on each site in order to level the land for development. The civil design had not been completed at the time of producing this report; however, it is assumed that the individual sites will be made relatively level with a cut to fill process. The likely cut and fill depths will vary across the six sites, but are anticipated to be minimal (in the order of 1 – 2 m) for Site 3 and the eastern halves of Sites 1, 2, and 5. Site 6 and the western halves of Sites 1, 2, and 5 may require more levelling, possibly stepped as terraces or with larger cutting and/or filling depths that may require some form of retaining in localised areas (2 m+, anticipated to be less than 5 m). These levels should be determined during civil design, however, are not anticipated to pose significant constraints to residential land development. Indicative areas of likely cut and fill depths are included in Figure 20, Figure 21, and Figure 22.

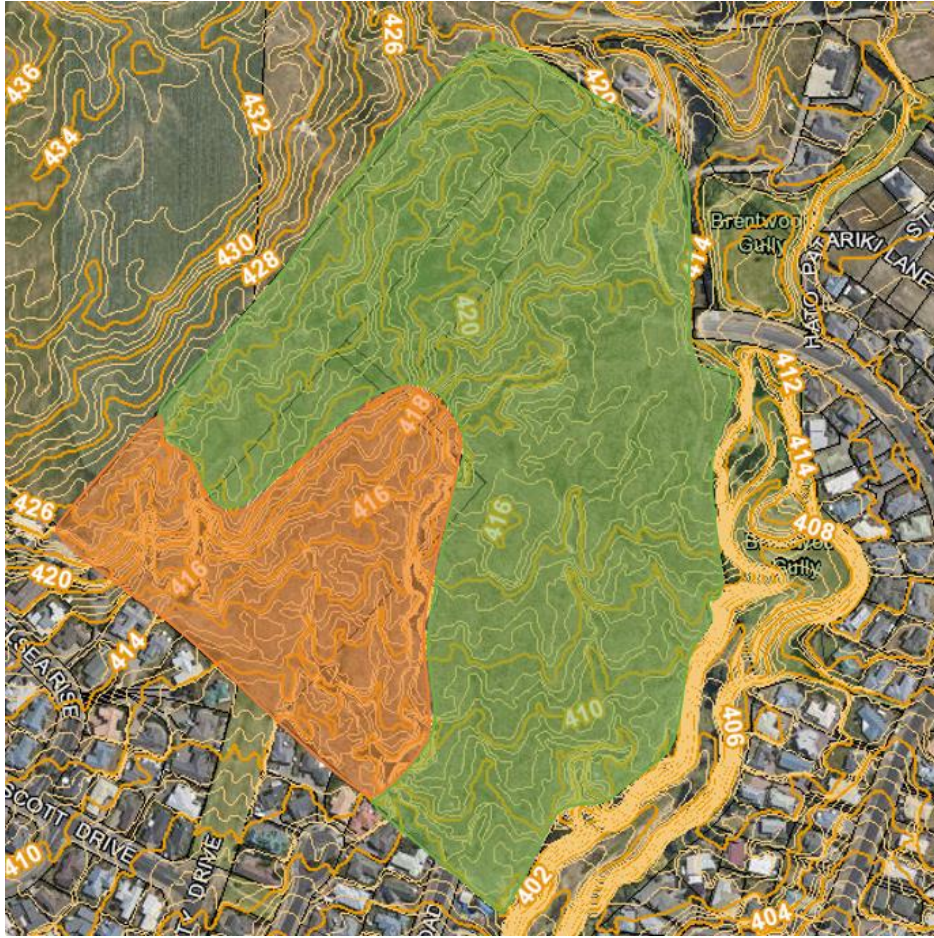
Figure 22: Indicative estimated cut and fill depth areas at Site 6 (green = estimated 1-2m, orange 2m+)

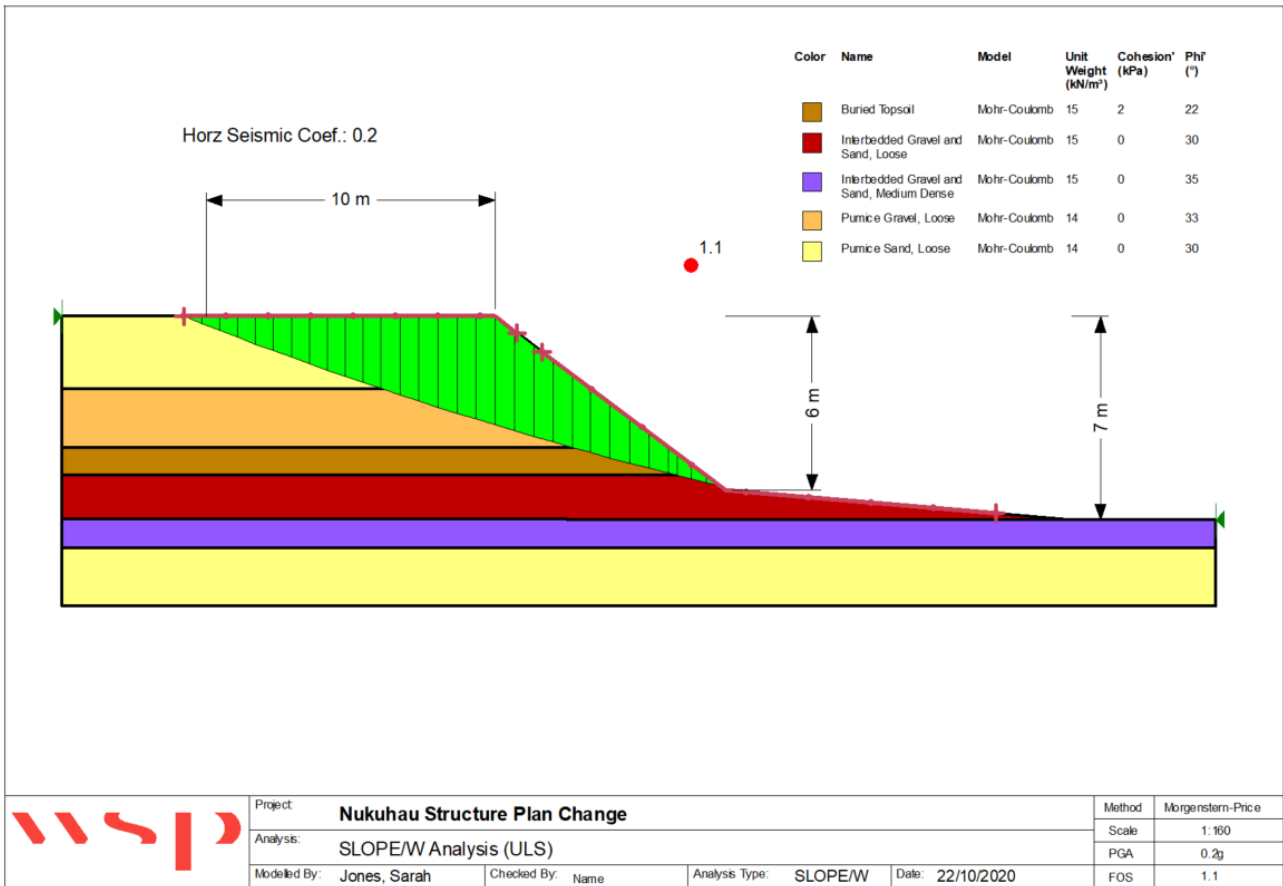
Figure 26: Slope Stability Model at Brentwood Gully Extension, ULS, failure 10m back from slope edge

Standard acceptable Factors of Safety (FOS) are considered 1.5 for static long term conditions, and 1.0 for ULS seismic conditions. Considering this, the results of this analysis, shown in Figure 23 and Figure 24, suggest that failures may encroach up to 6m back from the cliff edge in both the static and seismic cases. To address this potential issue, it is recommended that lots are offset 10 m from cliff edges. Figure 25 and Figure 26 give indications of the FOS of a failure encroaching 10m back from the slope crest in both static and ULS seismic cases, and both are above standard acceptable limits.

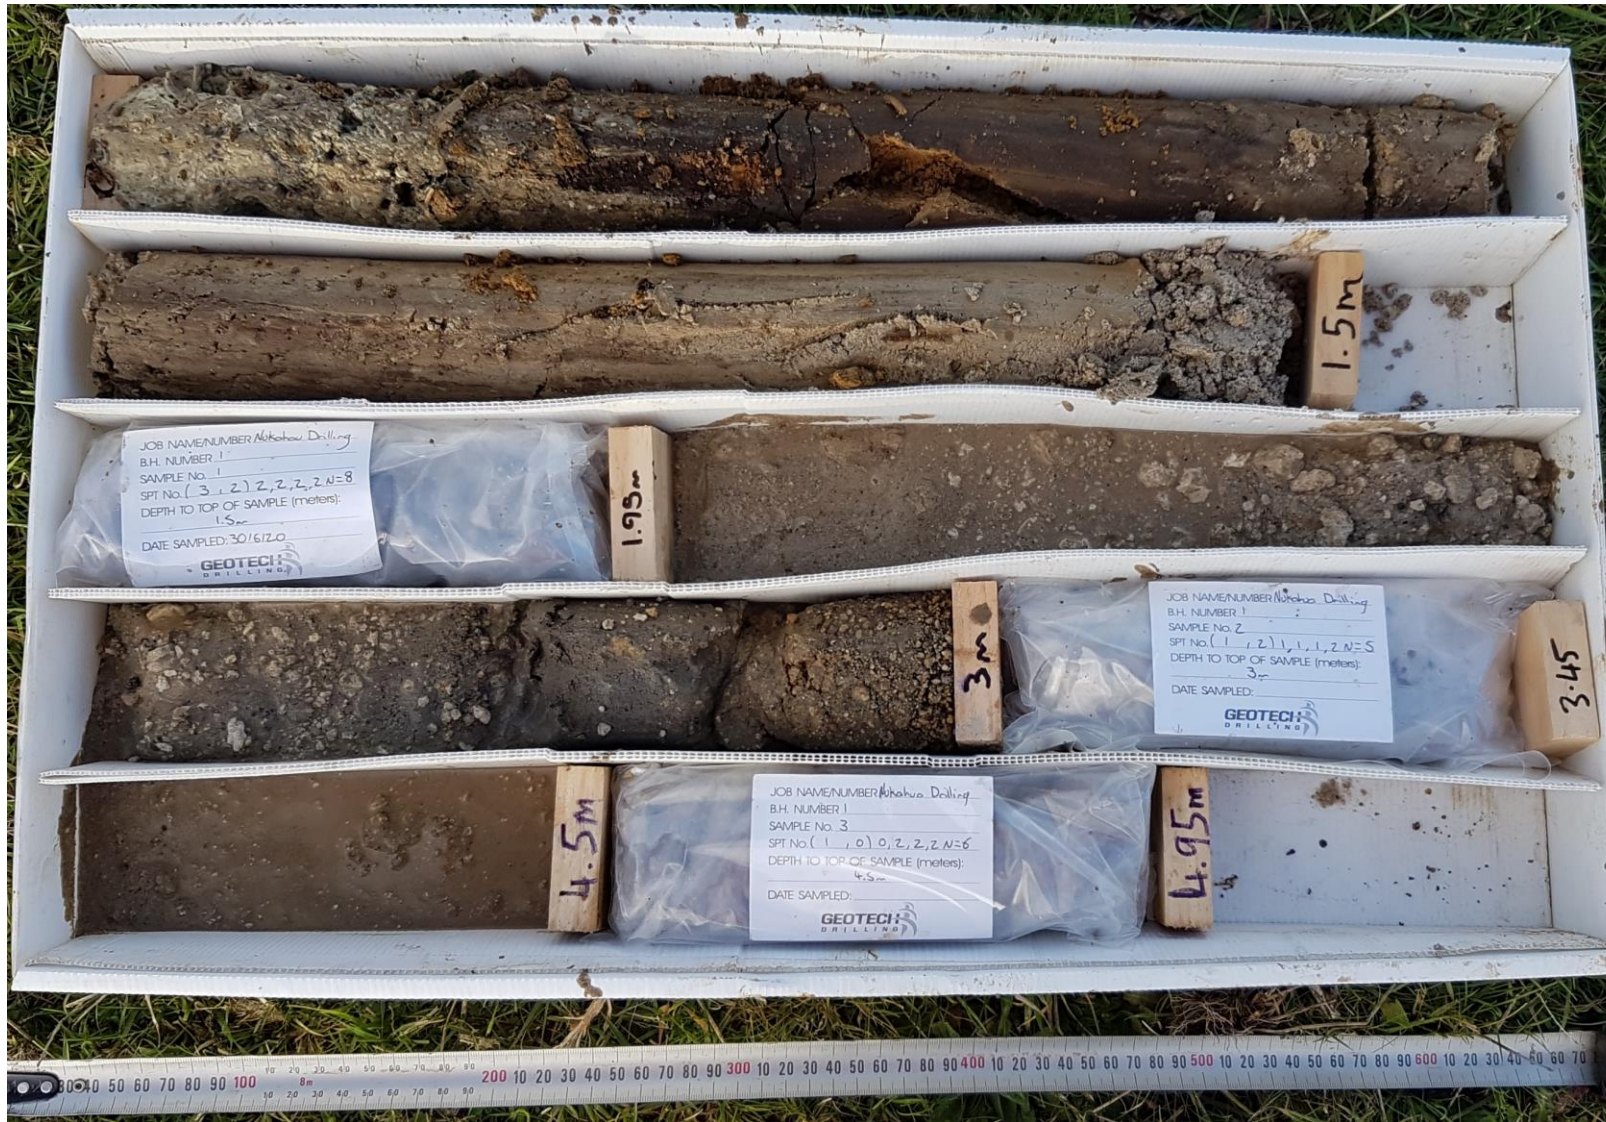
Location: Nukuhau Borehole: BH01

Depth: 0.00-4.95m bgl

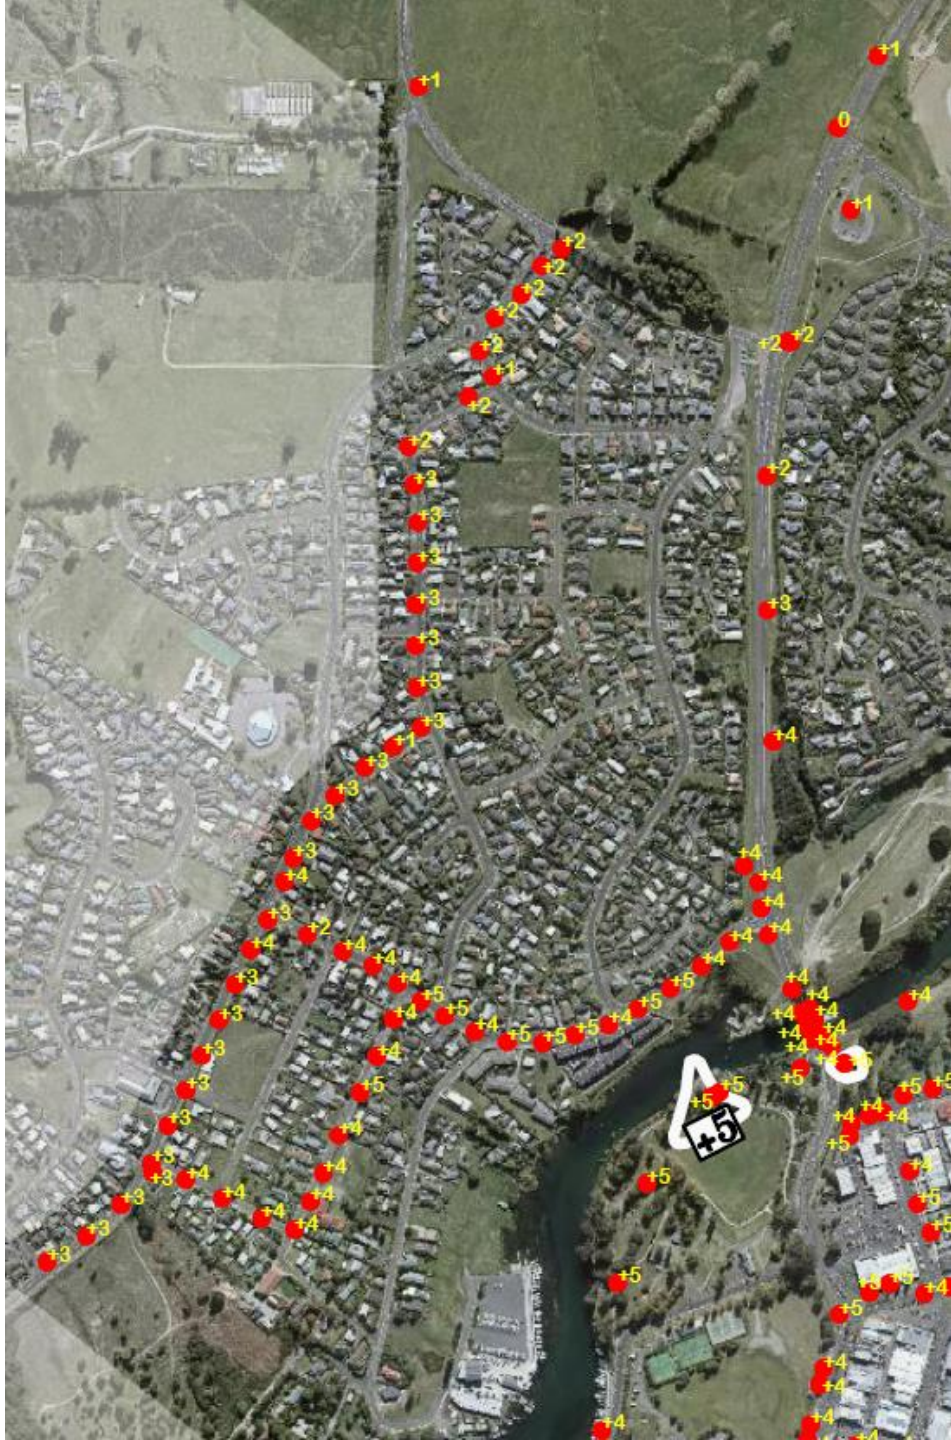
- BM levelled in Feb-2017 showing rate of ground level change in mm/yr for Jan-2015 to Feb-2017 period
- BM new or first time levelled after Jan-2015 survey
- existing BM not levelled in Jan-2015 or Feb-2017 surveys

- contour interval is 5mm/yr
- negative values show subsidence
- origin for Jan-2015 survey is A93 (Aratiatia) *
- origin for Feb-2017 survey is A93 (Aratiatia) *
