**Project Name: Nukuhau Plan Change**

**Project Number: 2-37400.00**

**Date: 27/10/17, Site Visit 21 February 2019**

**Background**

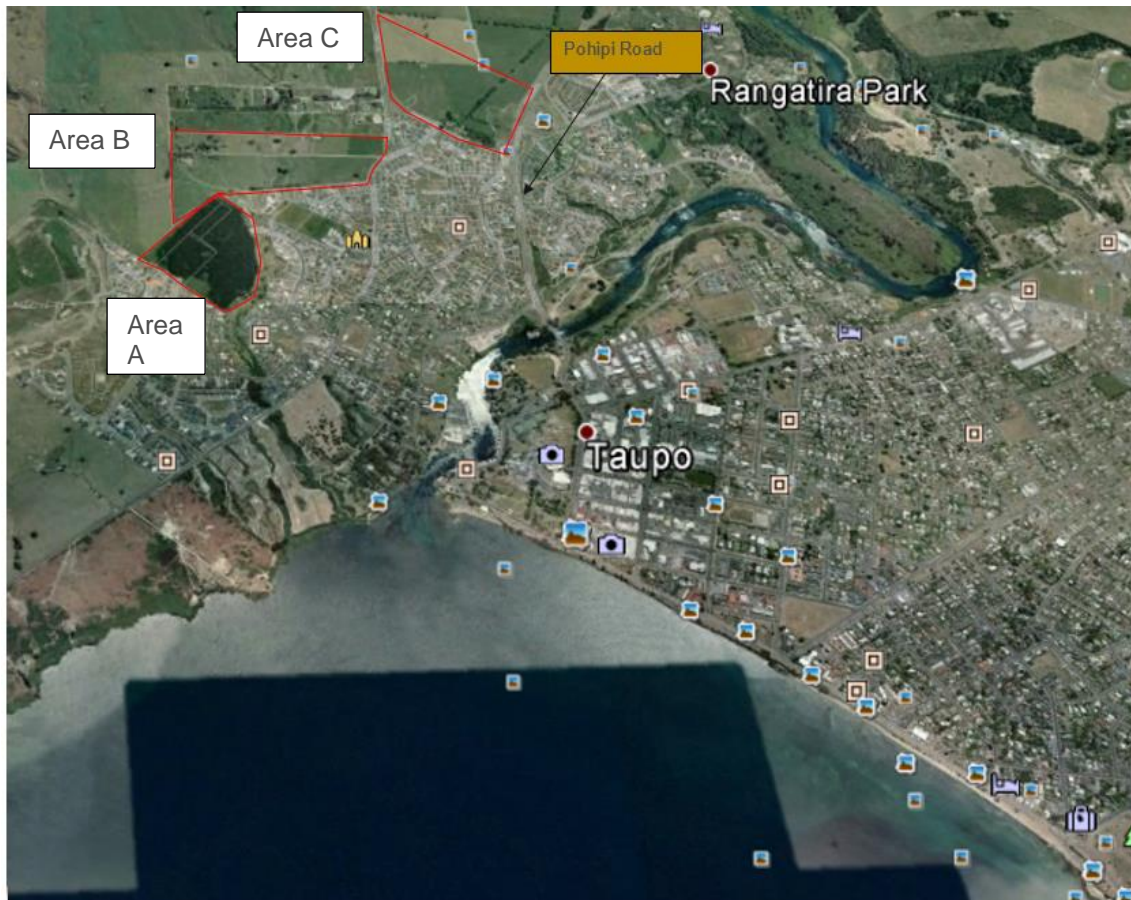
Figure 1: Areas of proposed re-zoning in Nukuhau, indicative area designations are outlined in red (Source: Tanya Running)

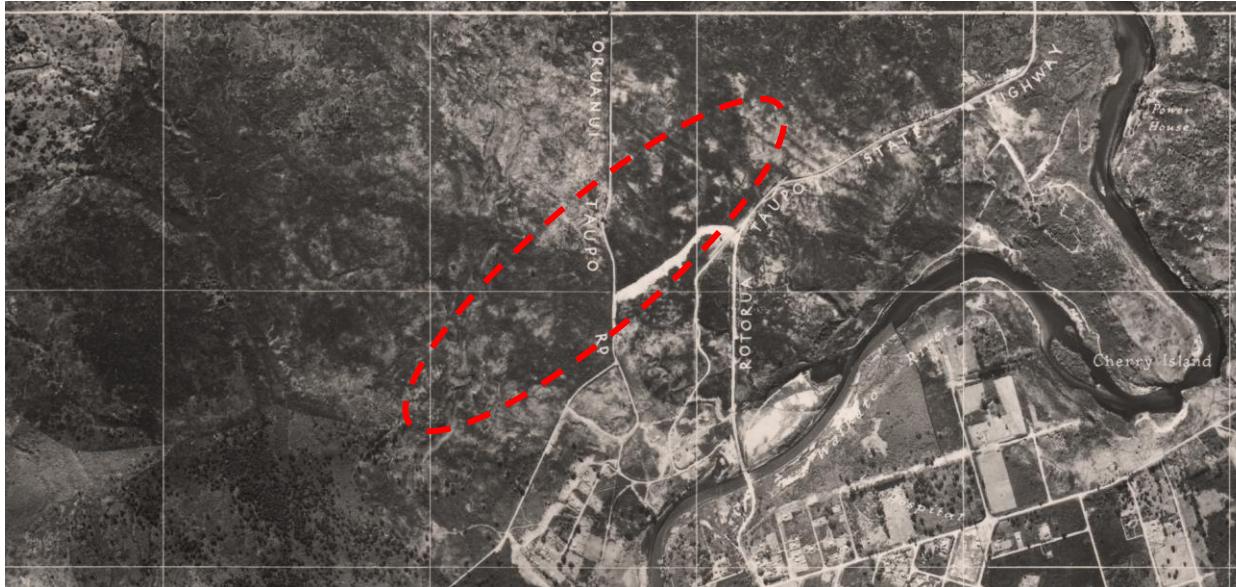
A brief desktop assessment was undertaken of publicly available historic aerial photographs for the area. The earliest image located was 1955 showing the area of proposed re-zoning as rough pasture or scrubland. The quality of the image and the nature of the ground cover make it impossible to identify any archaeological features present at surface level, had they been there (Figure 4).

Figure 4: Indicative area of proposed re-zoning (red dash), ground cover and image quality are obscuring any evidence of surface archaeological features in 1955<sup>1</sup> (Source: <https://qdh.auckland.ac.nz/maps>).

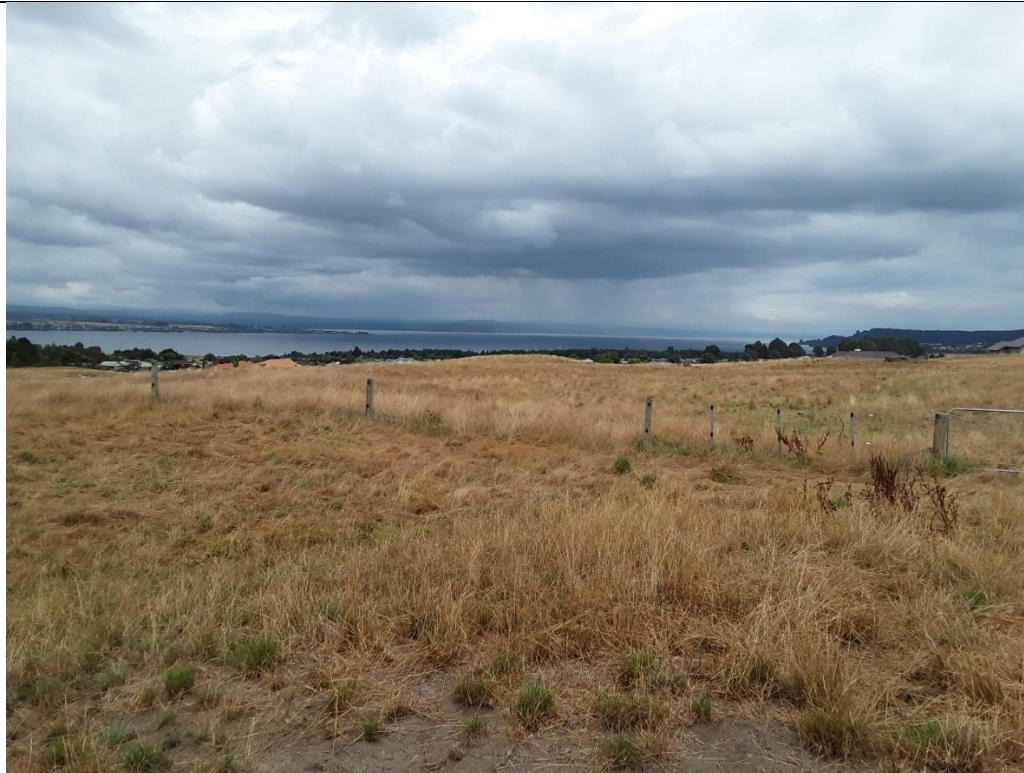
**Results**  
The size of the project area meant that the full area was unable to be comprehensively surveyed. While no archaeological material was noted during the site inspection, the ground was considered to be mainly intact. The land is primarily currently in pasture (Figure 8) and visibility was good.  
The wider landscape was extensively used prior to 1900 by Māori. While no specific archaeological risk was identified, there remains residual risk for the project area due to the wider landscape and project land size.  
This risk could be further clarified by a comprehensive archaeological survey.

Figure 8: View towards Lake Taupō from Area A.

Archaeological Assessment
