IN THE MATTER of a hearing for the Proposed Private Plan Change
37: Nukuhau to the Taupō District Plan

STATEMENT OF EVIDENCE OF JON PALMER
For the Waikato Regional Council
DATED 27 OCTOBER 2021

Appendix 1: Photos of recent erosion events in and around Taupō

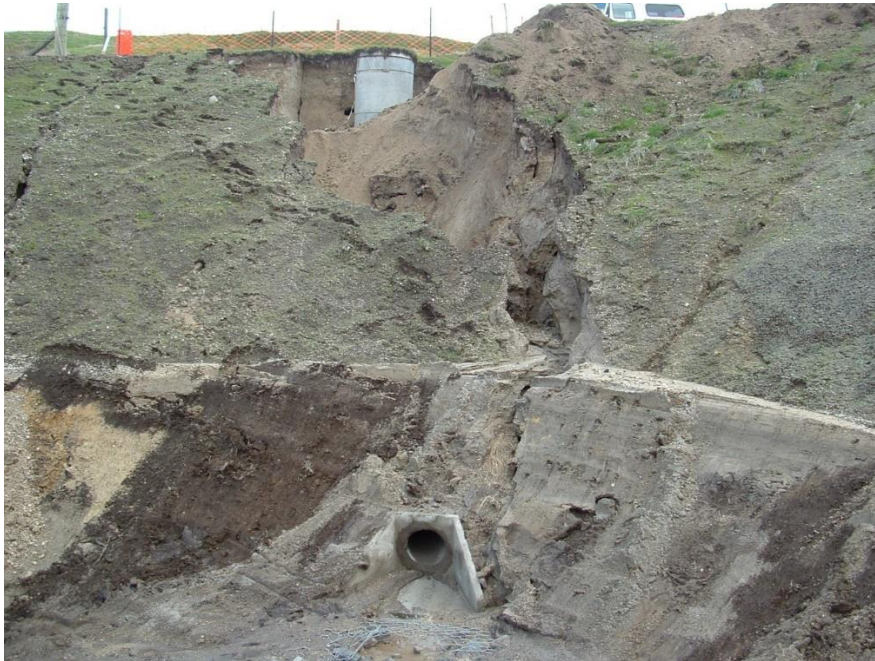
Loch Views Subdivision, blowout of drop structure. Catchment of 2 hectares. 2013.

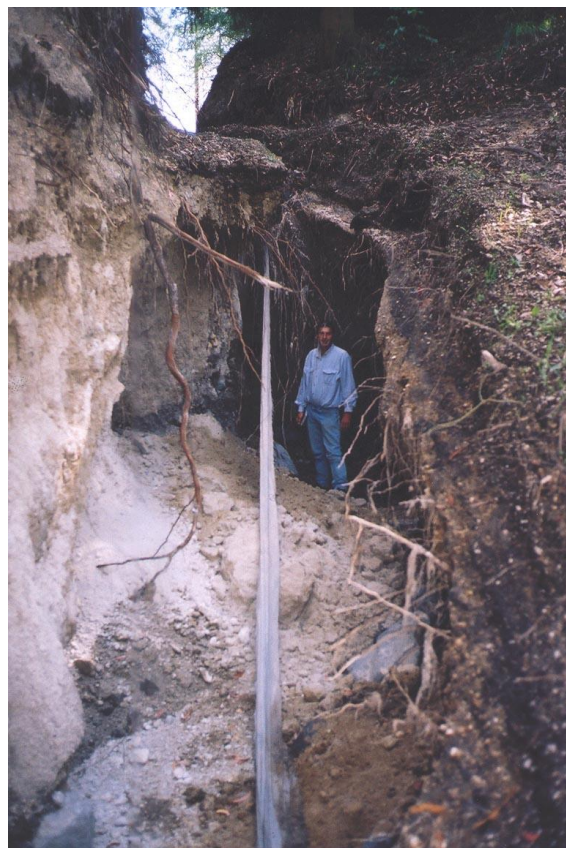
Loch Views Subdivision, damage to soil conservation gully following inappropriate stormwater control, 2013.

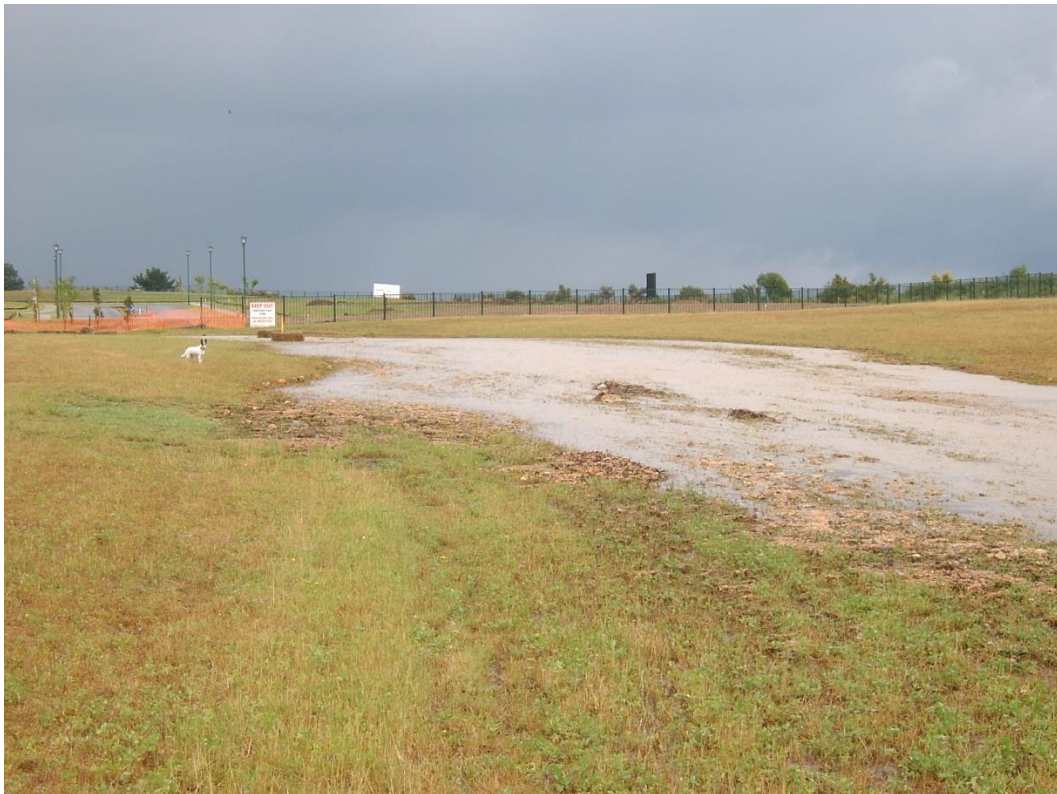
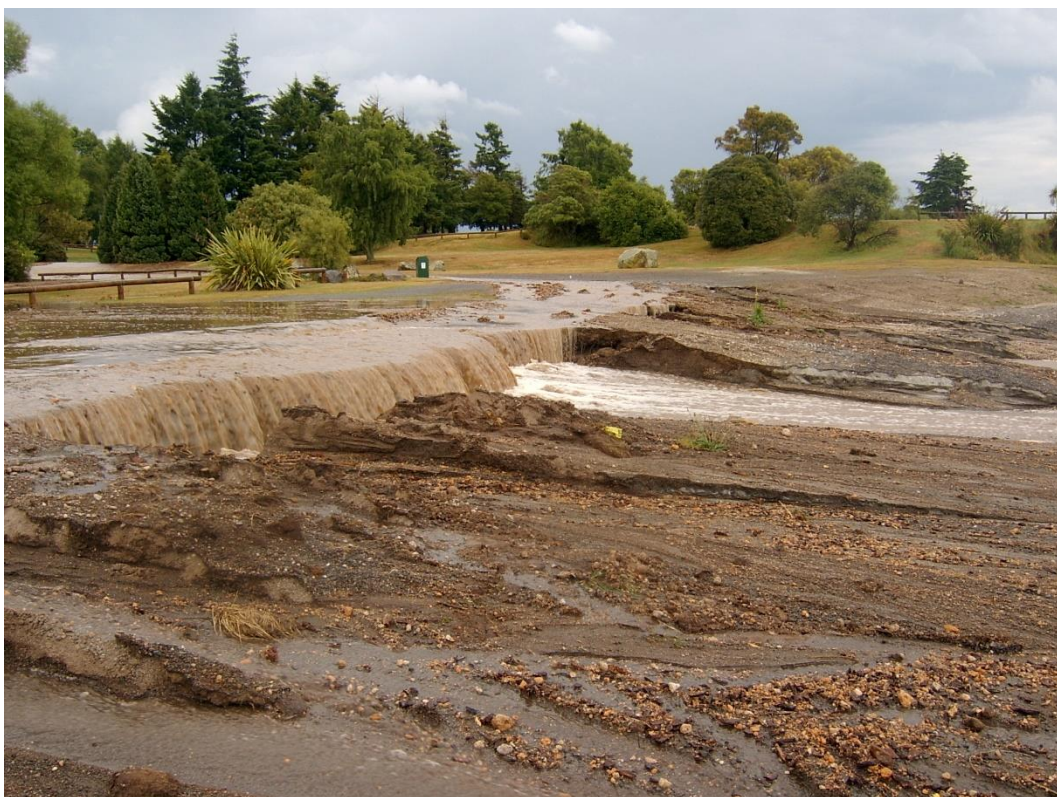
Wharewaka Subdivision, May 2013. Runoff from the subdivision into Lake Taupō at Wharewaka Point. Catchment size less than 50 hectares in a catchment with no defined gullies.

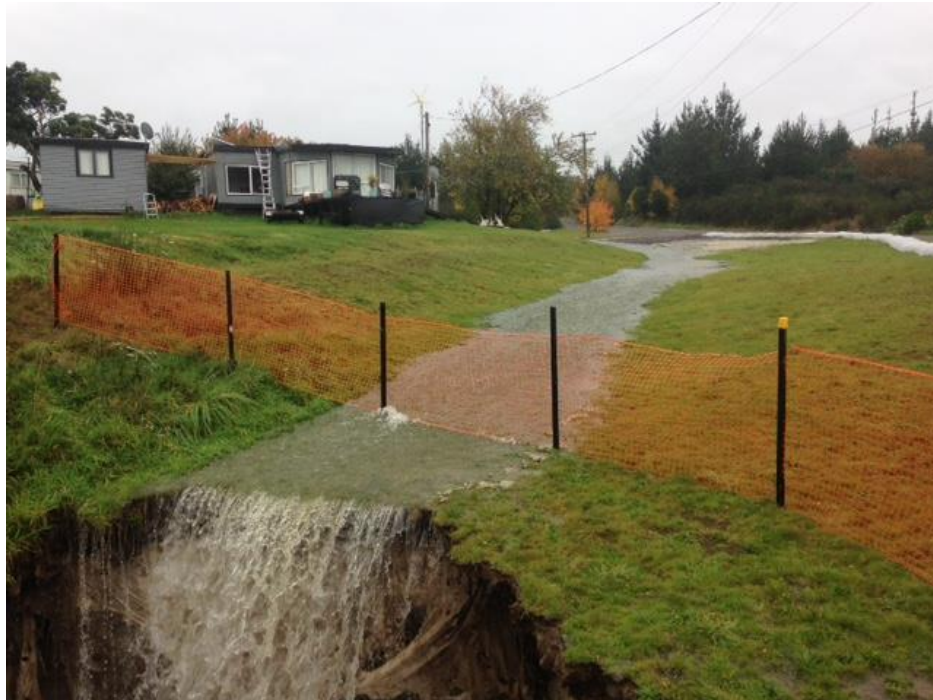
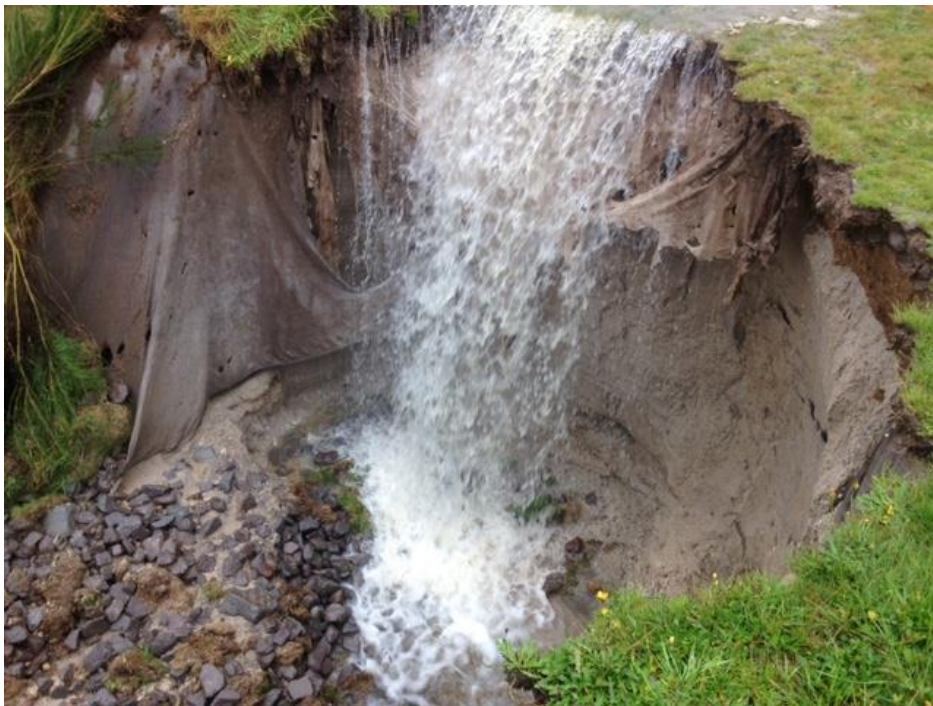
Paenoa Road, Acacia Bay, May 2017. Cyclone Debbie. Overland flows and gully erosion of geotechnically protected area.

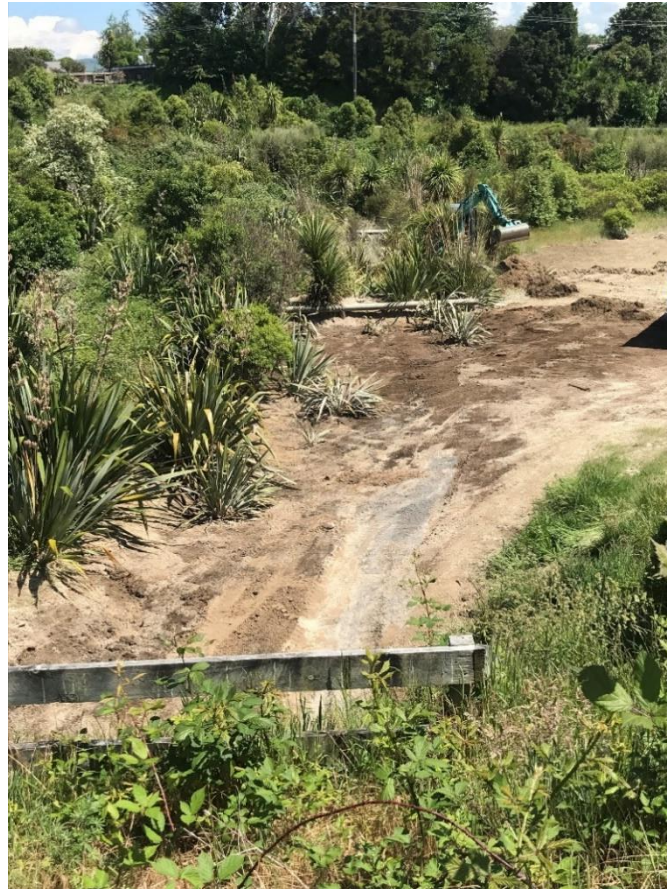
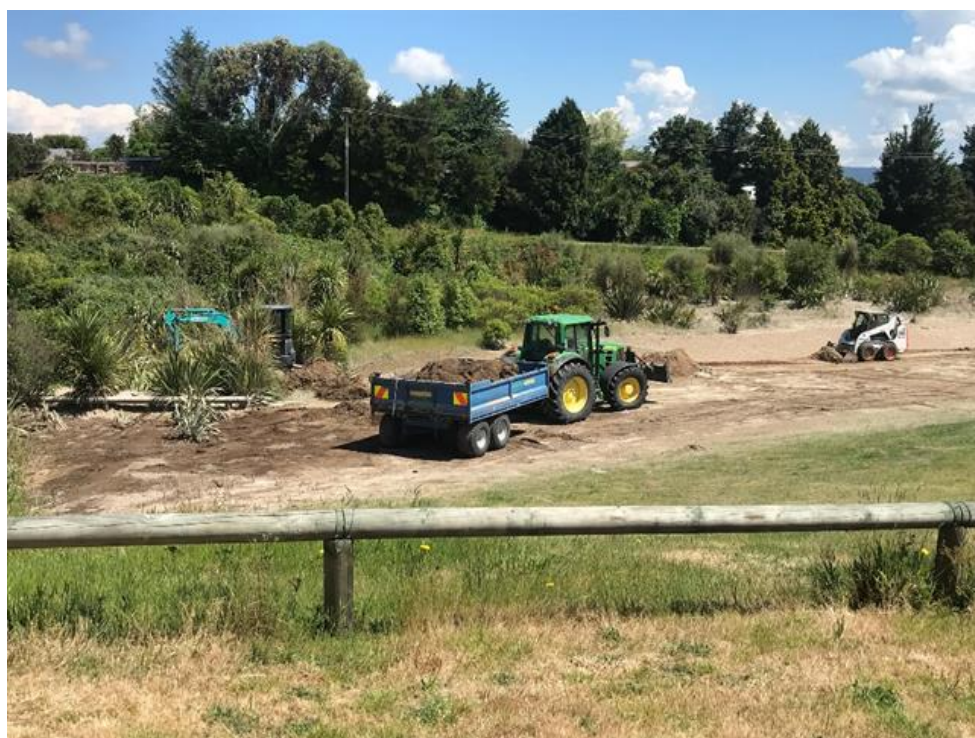
Wharewaka East, post storm event, December 2017. Debris from flows through gullies adjacent to Maunganamu Drive into Secombe Park (soil conservation areas protected by Land Improvement Agreement). The gullies hadn't flowed for many years. Upper catchments (200ha) planted in *Pinus radiata*.

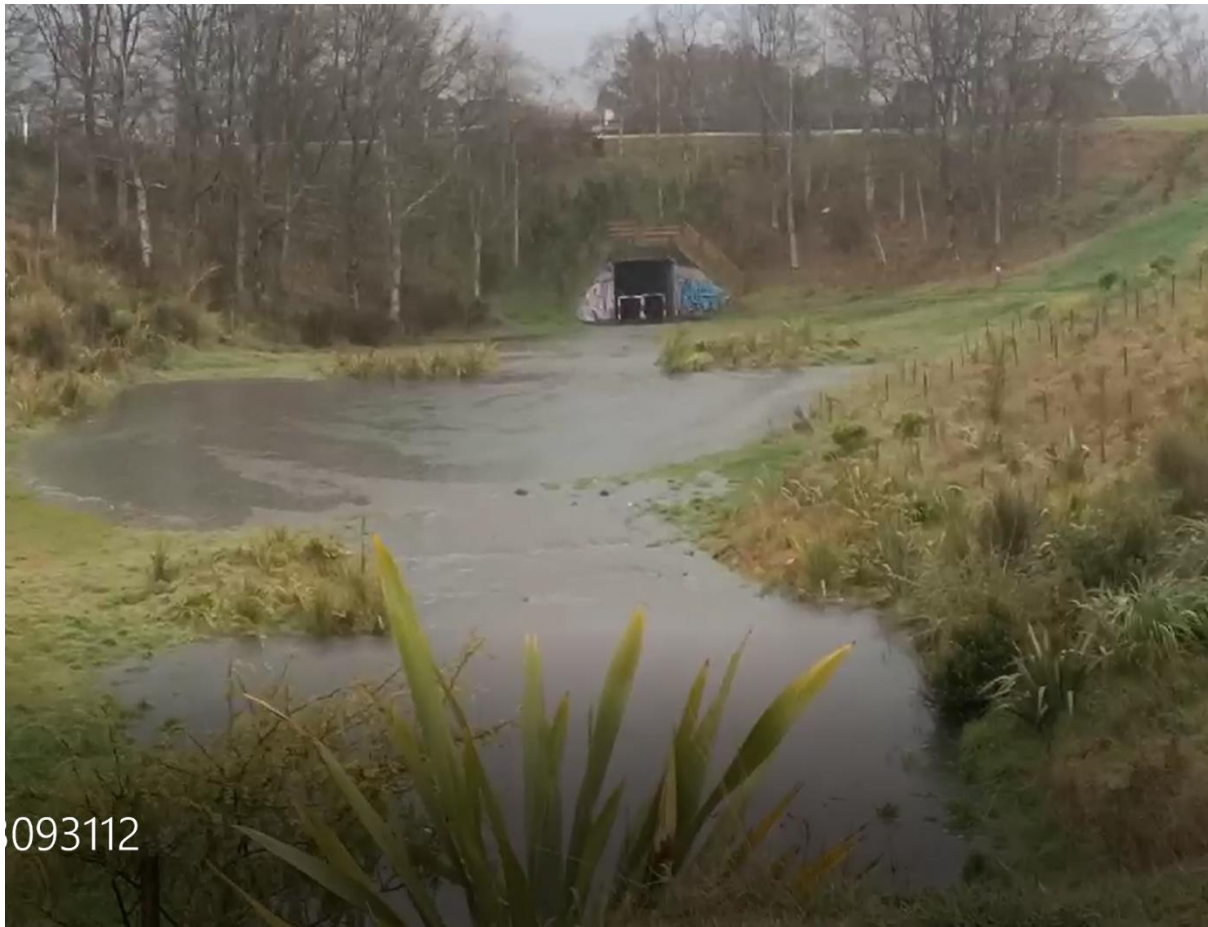
Wharewaka east subdivision. A “dry” gully carrying water after a short heavy rain event. September 2021.

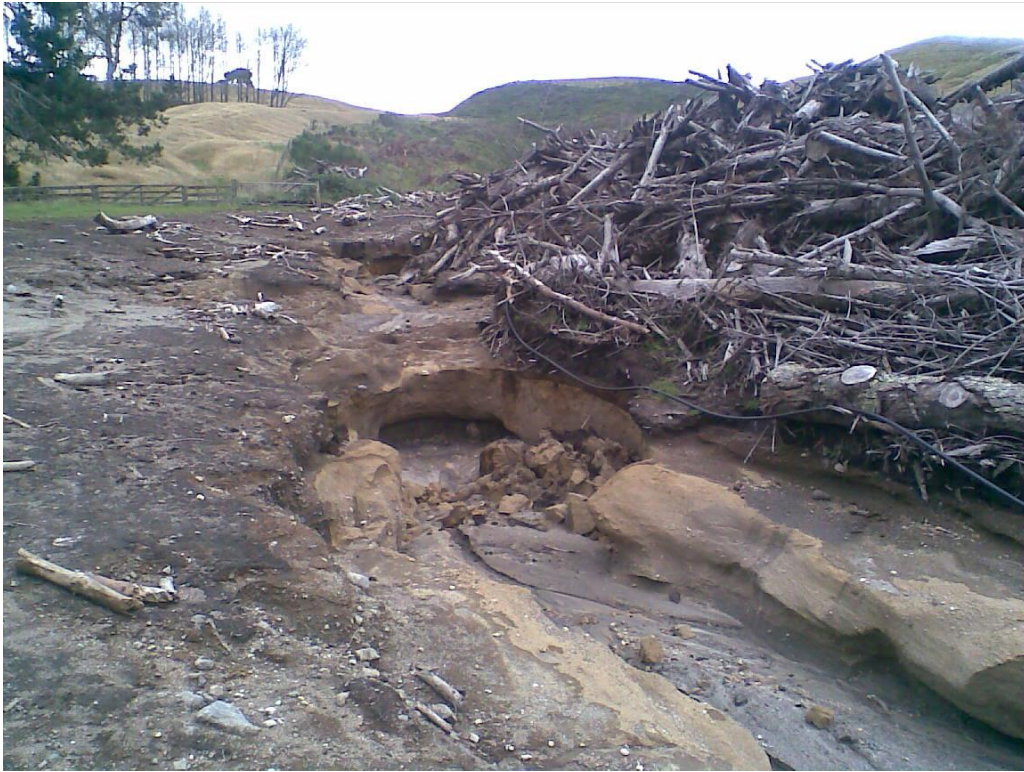
Upper Nukuhau erosion caused by stormwater within a gully system with no vegetative protection, 2012.

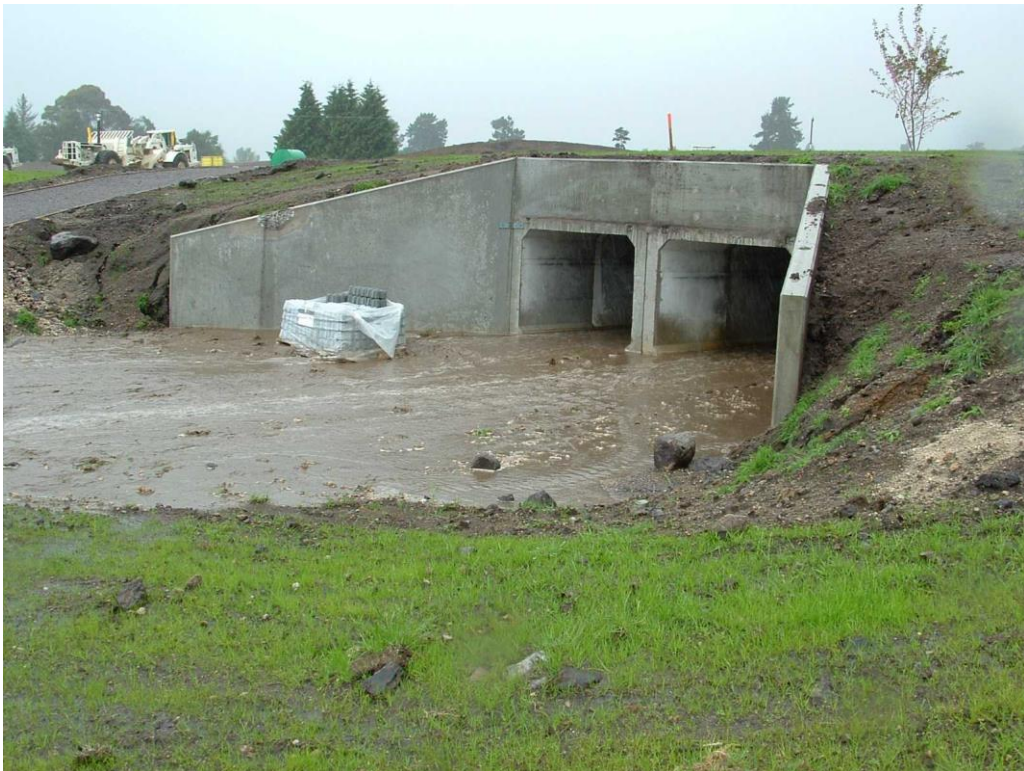
Loch Eagles Subdivision, 2013. Large volume of pumice debris following a downpour during subdivision development.

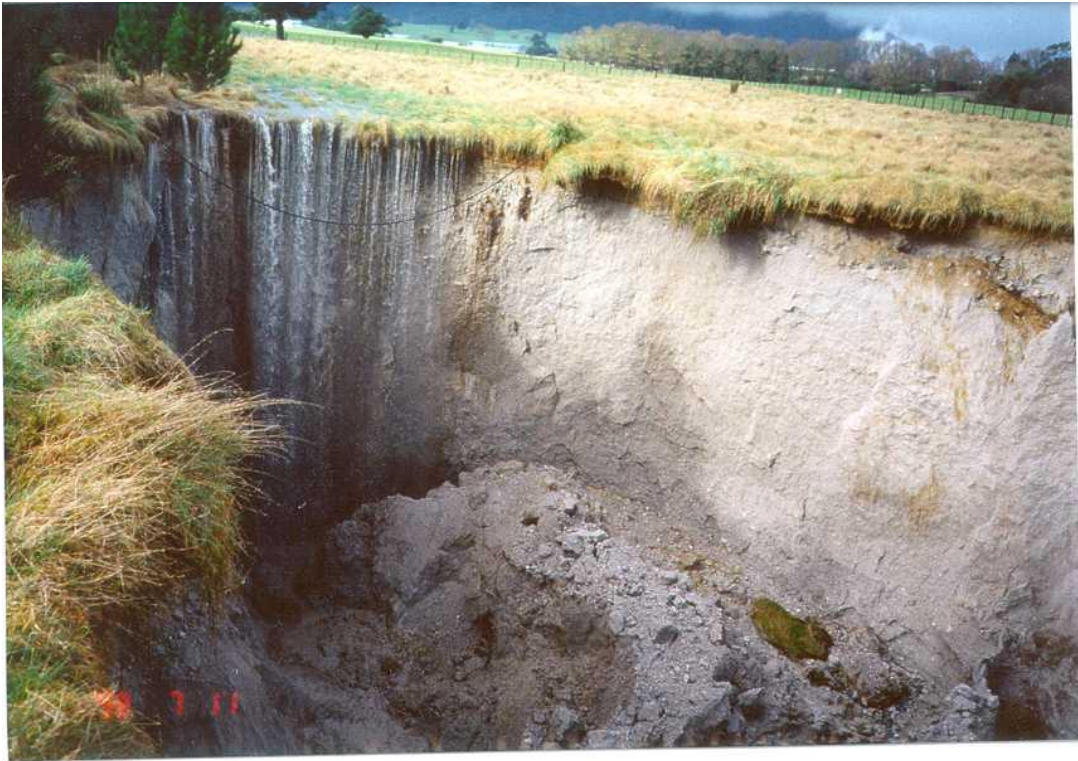
Rakanui Road TH2, Gully erosion of a benign landscape after a heavy rain event in the early 2000s.

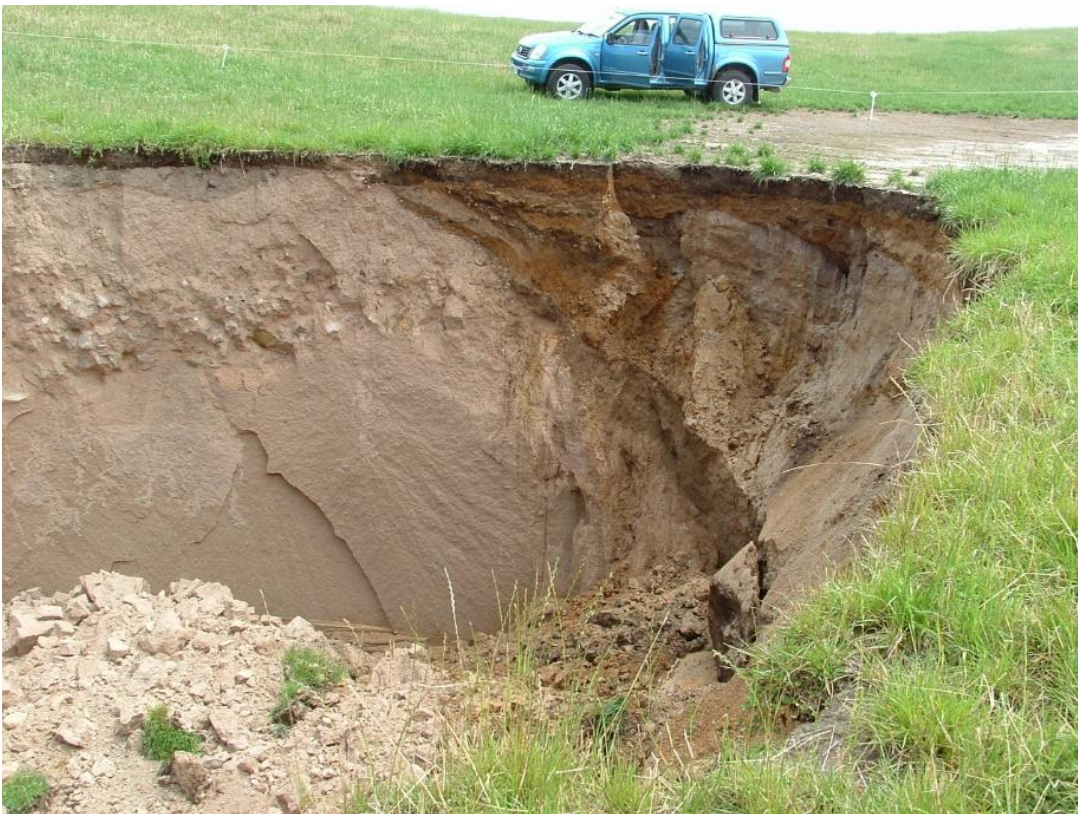
Farmland near Taupō, gully erosion of benign landscape in a catchment with previous gully erosion. Catchment size approximately 100 ha.

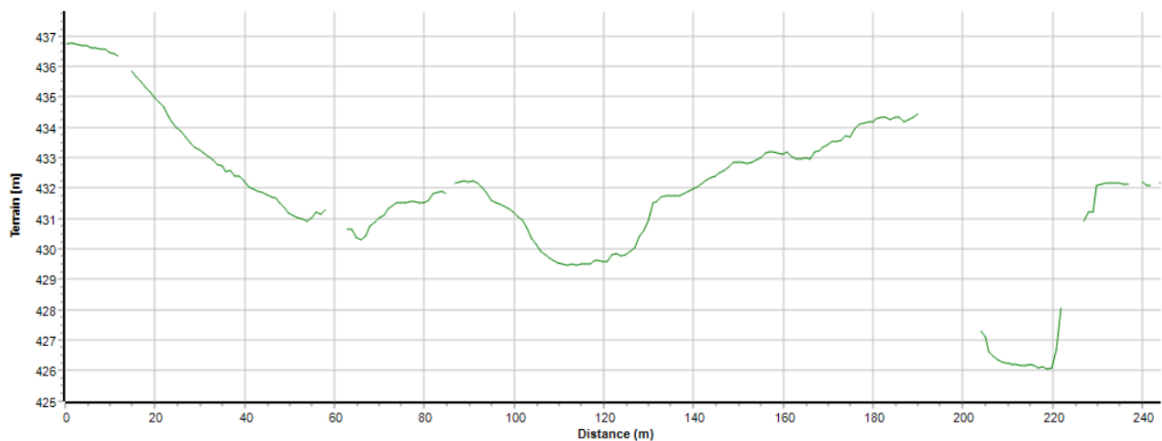
Graph of Nukuhau gully terrain

3 main catchments to northern property boundary							
East	111.4 2 ha	40minT C	100y42.4m m	C=0.1_Qp1. 97	C=0.3_Qp5. 91	C=0.9_Qp17. 73	NZFloodSta ts Qp0.41
Mid	127.4 6 ha	40min TC	100y42.4m m	C=0.1_Qp2. 25	C=0.3_Qp6. 74	C=0.9_Qp20. 21	NZFloodSta ts Qp0.64
West (and mid- old)	21.95 + 1.1 ha	20min TC	100y31.2m m	C=0.1_Qp0. 60	C=0.3_Qp1. 79	C=0.9_Qp5.3 8	NZFloodSta ts n/a

The east and mid catchments join naturally, with a total catchment area of 239ha. Addition of the west catchment brings the total area to 262ha, which is an increase of around 9%.

32. As the gullies have conveyed water flows in the past, it is likely significant flows will also be conveyed by these gullies in the future, during and following storm events. This is also suggested by modelling (see Appendix 2). The volume of flow is likely to be exacerbated by an increase in hard surfaces in the area after urban development, particularly in instances where on-site water retention and other stormwater mitigation measures are compromised. This creates risk of flooding and erosion.
