Before the Independent Hearing Panel  
at Taupo

*in the matter of:* Proposed Plan Change 36 to the Taupo District Plan –  
Request under Schedule 1 of the RMA to rezone Rural  
Land to Residential at Whareroa North by The  
Proprietors of Hauhungaroa No. 6

Statement of Evidence by Harshad Phadnis on behalf of The Proprietors of Hauhungaroa No.6

29 April 2020

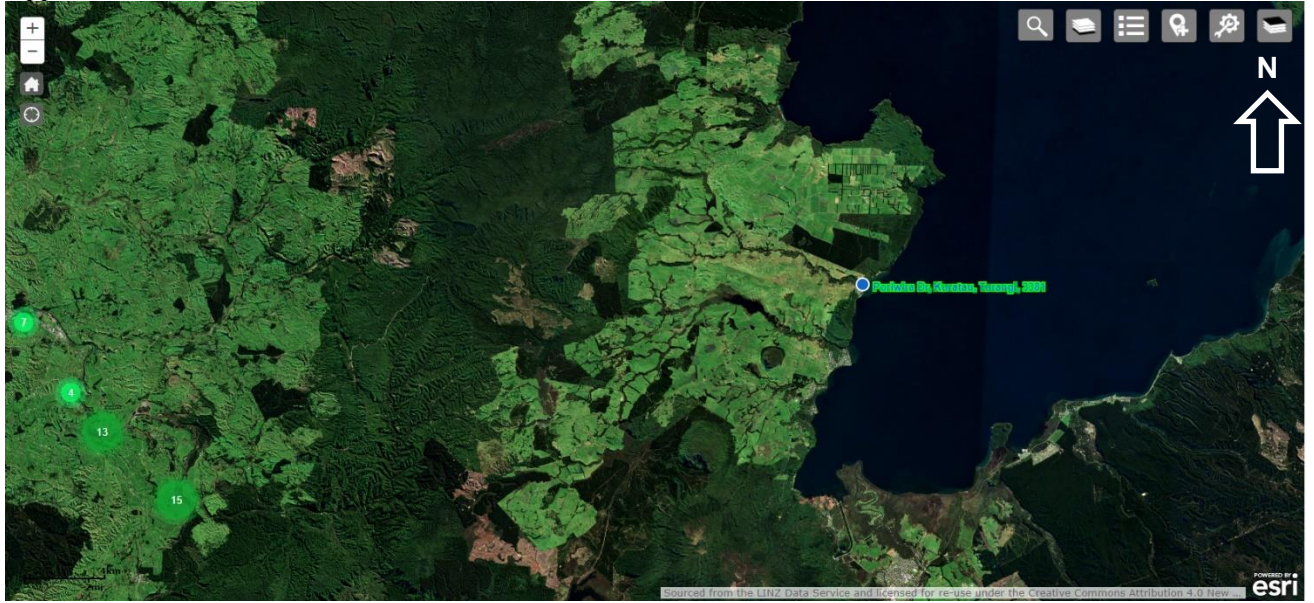
Appendix 3: Information available on NZGD

- 4.3. The New Zealand Geotechnical Database (NZGD), which is a free-to-use online database of geotechnical information funded by the Ministry of Business, Innovation & Employment, was checked for geotechnical information in the vicinity of the site. As seen in Appendix 3, the nearest geotechnical information on NZGD is approximately 30 kilometres away and due to the distance, this information was not used in this statement of evidence.

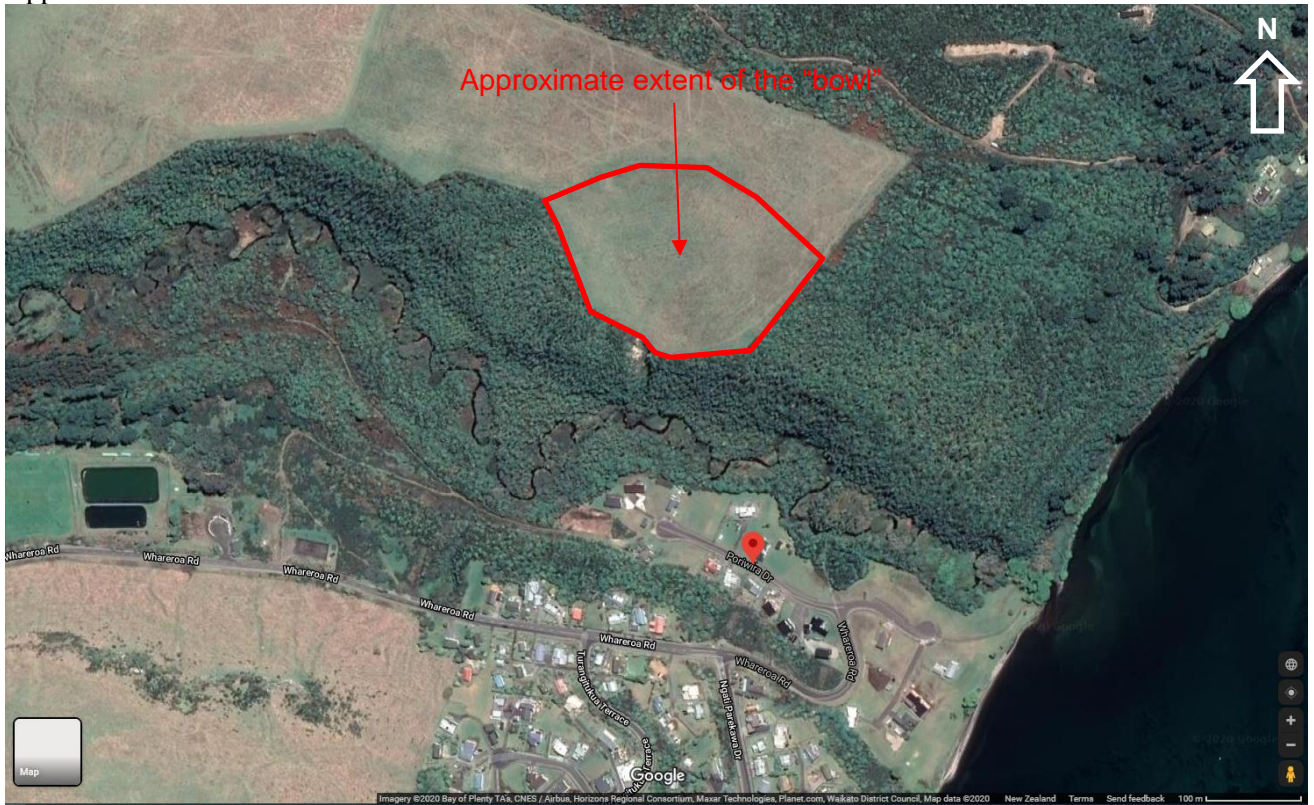
Appendix 8: The “bowl” at the site

- 6.1. Mark T Mitchell Limited performed investigations to determine the stratigraphy at the low-lying area which has been referred as the "bowl" (as shown in Appendix 8) and determine special conditions required, if any, if the "bowl" is to be filled. The results including geotechnical logs from seven test pits performed up to 4.8 metres below the ground level when the test was conducted (mbgl) are summarised in Ref. 1.6.3 which has been presented as Appendix 5. Filling the "bowl" is no longer a part of the proposal but this change was not driven by any geotechnical issue(s).

- 6.4. Ref. 1.6.3 concludes that the "bowl" is a natural bench feature created by welded ignimbrite bedrock being mantled by younger aeolian tephra which has undergone some down-slope movement which is likely to have occurred after the tephra were deposited i.e. approximately around 181 A.D. The aeolian tephra is likely to be compressible, and this is discussed further in Section 9.8 - 9.13 of my evidence. The October 2006 Mitchell Report also concludes that the "bowl" area is stable.

- 7.2. The scar was tracked back to 1969 A.D where it is first seen in photographs. The scar has potentially been formed by an ephemeral drainage path which saturated the loosely packed material at the base which were then eroded by the former course of the Whareroa Stream over time. This then undermined the upper soils i.e. soils near the crown of the scar, and this process continued to form the scar. This is anticipated to extend back (i.e. to the north) by at least 15m before reaching its equilibrium position and hence, any stormwater pond(s) (including the maximum extent of batters) should be beyond this distance. The process is anticipated to be longitudinal i.e. from south to north and not lateral.

- 7.3. Ref. 1.6.4 concludes that surface runoff from the “bowl” has a low potential to incise the scar, however, infiltrated runoff creating underground flow paths is likely to (if allowed to continue) incise the scar and affect any proposed development located within the “bowl”. I believe that careful design of the stormwater management system for the development area (once the geotechnical investigations detailed later in my evidence are complete) can prevent this from occurring.

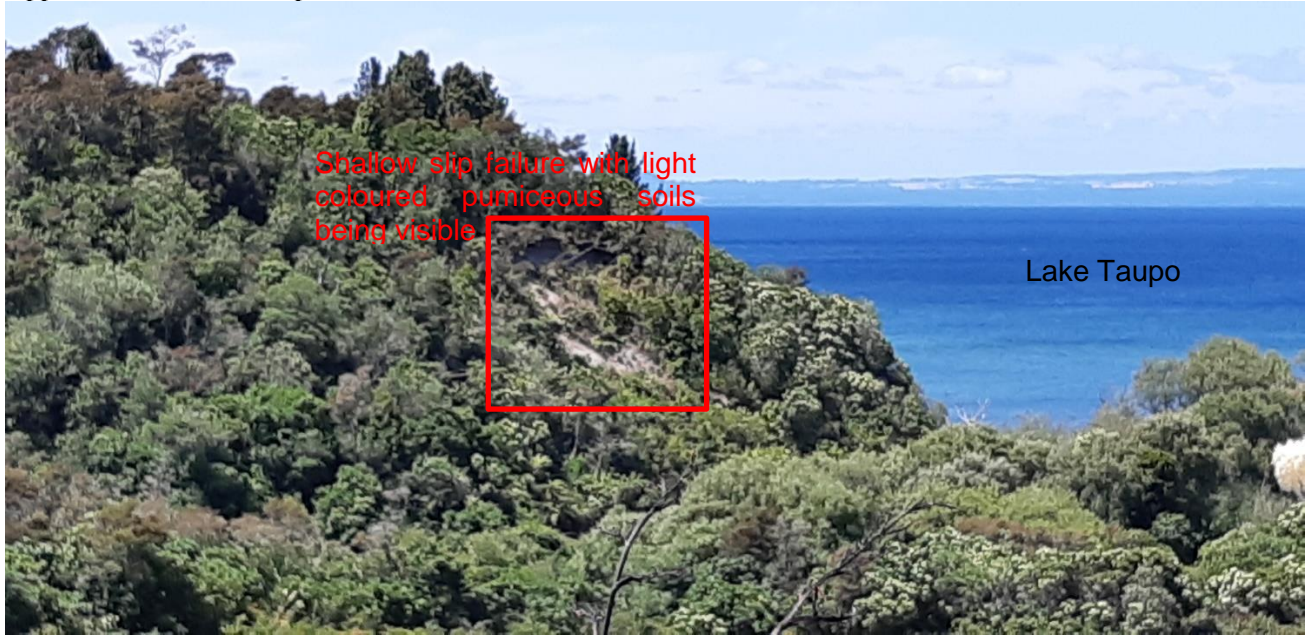
Appendix 9: Shallow Slip Failure

Cuts along the access road	I consider that the general stratigraphy through the area where the access road is proposed will be colluvium underlain by silt/sand. These upper layers are susceptible to shallow slope failures (as seen in Appendix 9) when they are not held together by grass or tree roots and/or during rainfall events. I consider that "unstable ground", "land slip" identified	If the machine drilled boreholes along the access corridor (discussed in Section 9) signal that gravel layers exist in the area, then, in my opinion, this represents the worst-case scenario. If gravels are encountered in minor volumes during investigations/construction, excavation and removal of the gravels will be

<p>by submitters is likely to be these shallow slope failures. These will be underlain either by Taupo Pumice Formation ignimbrite and Oruanui Formation ignimbrite. Based on my experience of pumiceous soils in and around Taupo, I consider that pumiceous soils/ignimbrite can stand up very well at slopes (batters) of 1:4 (1 horizontal to 4 vertical) (refer Appendix 10). If the cut heights are greater than 5m, then benching (terraces), with a minimum width of 3m, should be utilised.</p>	<p>required. If gravels are encountered across significant lengths of the section, excavation and removal cannot be used and then appropriate retaining solutions will need to be designed and built.</p>
Surface Runoff	<p>Stormwater from a 1% AEP event will be conveyed via the road reserve to an attenuation pond which will discharge from the pond via sheet flow that will be restricted to the pre-development 10% AEP flow rate well away from the scar as mentioned in Ref. 1.6.5. Additionally, surface runoff has a low potential to incise the scar as per Ref. 1.6.4. Based on high friction angles of pumiceous material and no major instabilities being observed away from the scar, it is considered that the ground between the pond and the bank will be stable and be able to accommodate periodic sheet flows from the pond. Hence, I consider that worsening of the scar due to surface runoff as well instability of the ground between the pond and the bank will not occur and this scenario is referred as the typical scenario. These details will be assessed as a part of geotechnical investigations and analysed before the subdivision consent application is submitted.</p>	<p>If the erosion risk is considered to be high even if sheet flow is restricted to the pre-development 10% AEP flow rate, the outflow swale lengths can be increased so that sheet flow occurs over a larger ground area.</p> <p>Alternatively, the ponds can be relocated and sheet flows can be diverted over areas which are assessed to be stable.</p>

- 9.15. Dr. Ruth & Simon Ewen, Ian Sutcliffe, Robert & Jo Colman and Michael Townson Miller have submitted their concern about the proposed access road passing through an “unstable” area with evidence of slips. I consider that the general stratigraphy through the area where the access road is proposed will be colluvium underlain by silt/sand. In my view, only the upper layers are susceptible to shallow slope failures (as seen in Appendix 9) when they are not held together by grass or tree roots and/or during rainfall events. I consider that “unstable ground” and/or “land slip” identified by submitters is likely to be the result of these shallow slope failures. These will be underlain either by Taupo Pumice Formation ignimbrite and Oruanui Formation ignimbrite. Based on my experience of pumiceous soils in and around Taupo, I consider that pumiceous soils/ignimbrite can stand up very well at slopes (batters) of 1:4 (1 horizontal to 4 vertical) (refer Appendix 10). If the cut heights are greater than 5m, then benching (terraces), with a minimum width of 3m, should be utilised. This is considered as the typical scenario. A three-dimensional representation of cuts and fills involved for the proposed access road is presented in Appendix 11. Maximum cut height of 5m is shown with a bench width of 3m. The fill batters in the vicinity of the bridge are shown at slopes (batters) of 1.5:1 (1.5 horizontal to 1 vertical) which I consider to be appropriate for the expected (typical) scenario.
