TAUPO DISTRICT COUNCIL

**Taupo Urban, Commercial and
Industrial Structure Plan:
Geotechnical and Geo-
environmental Hazards, Rev 1**

November 2008

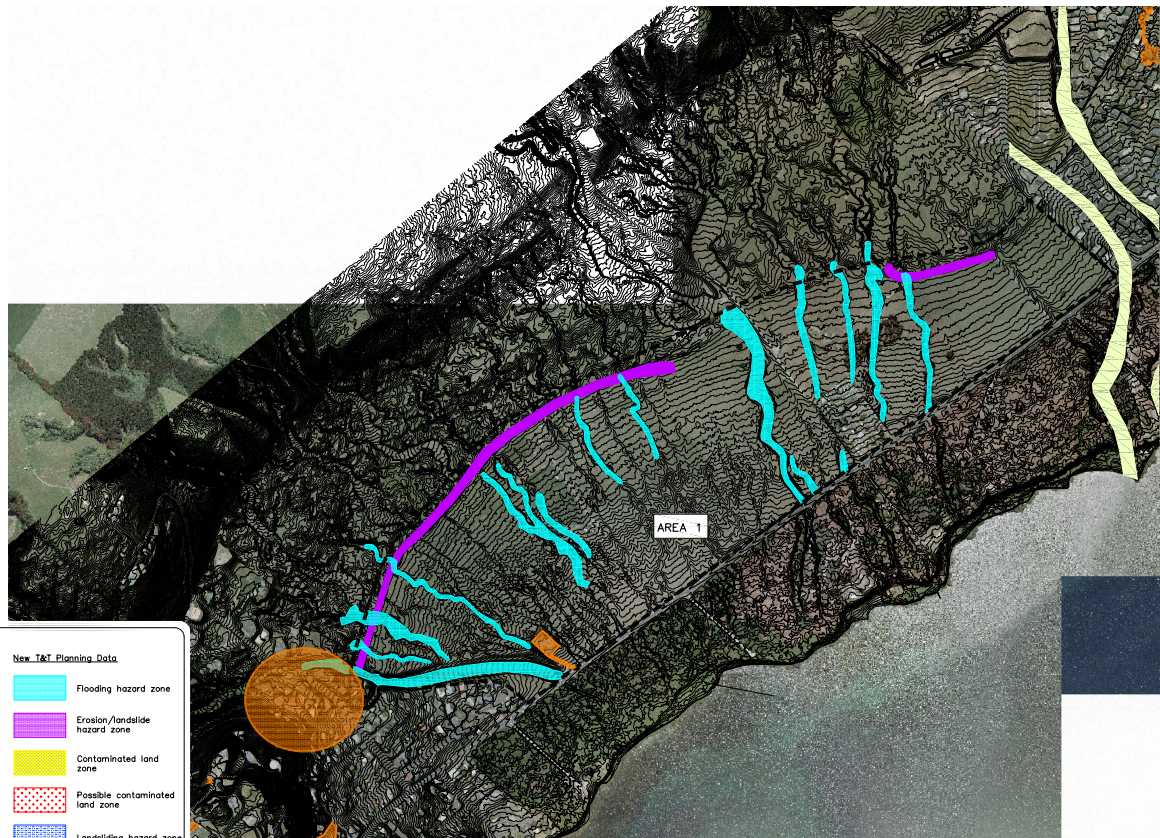
FIG. No. Figure 2

NOTES:
 1. Aerial photograph and contours provided by Taupo District Council.
 2. Hazard zones include those identified on the TDC District Plan and those identified during this study.

Erosion hazards are associated with moderately steep terrace slopes and steep gully sides. Debris was observed at the base of the terrace in Area 9 and is suspected to be present at the base of the terrace in Area 1. The steep gully sides are also considered susceptible to erosion due to overland water flow during heavy rainfall and due to seasonal processes. Zones of erosion hazard on the gully sides are generally coincident with areas also at risk of landsliding. These are located in areas 1, 4, 6, 7, 8, 9 and 10 (see Figures 2, 3, 4, 5 and 6).

Area 1 (see Figure 2)

Hazard	Description
Description	Rangitira East Land between Taupo and Acacia Bay. Proposed industrial area gently sloping, undulating land is between Acacia Bay Road and the first lake terrace.
Fault Lines	None identified.
Flood Hazard Areas	<ul style="list-style-type: none">- Flood hazards in incised gully systems.- Numerous shallow dry stream channels will need to be accounted for during drainage design.
Hot Ground Hazard Areas	None identified.
Land Instability - Landsliding	Low risk.
Contaminated or Potentially Contaminated Sites	None identified.
Erosion Hazard	Small erosion hazard along terrace edge.
Subsidence	None identified.
